Date: March 31, 2008

TO: Board Members – Vancouver Park Board
FROM: General Manager – Parks and Recreation
SUBJECT: Stanley Park Hollow Tree

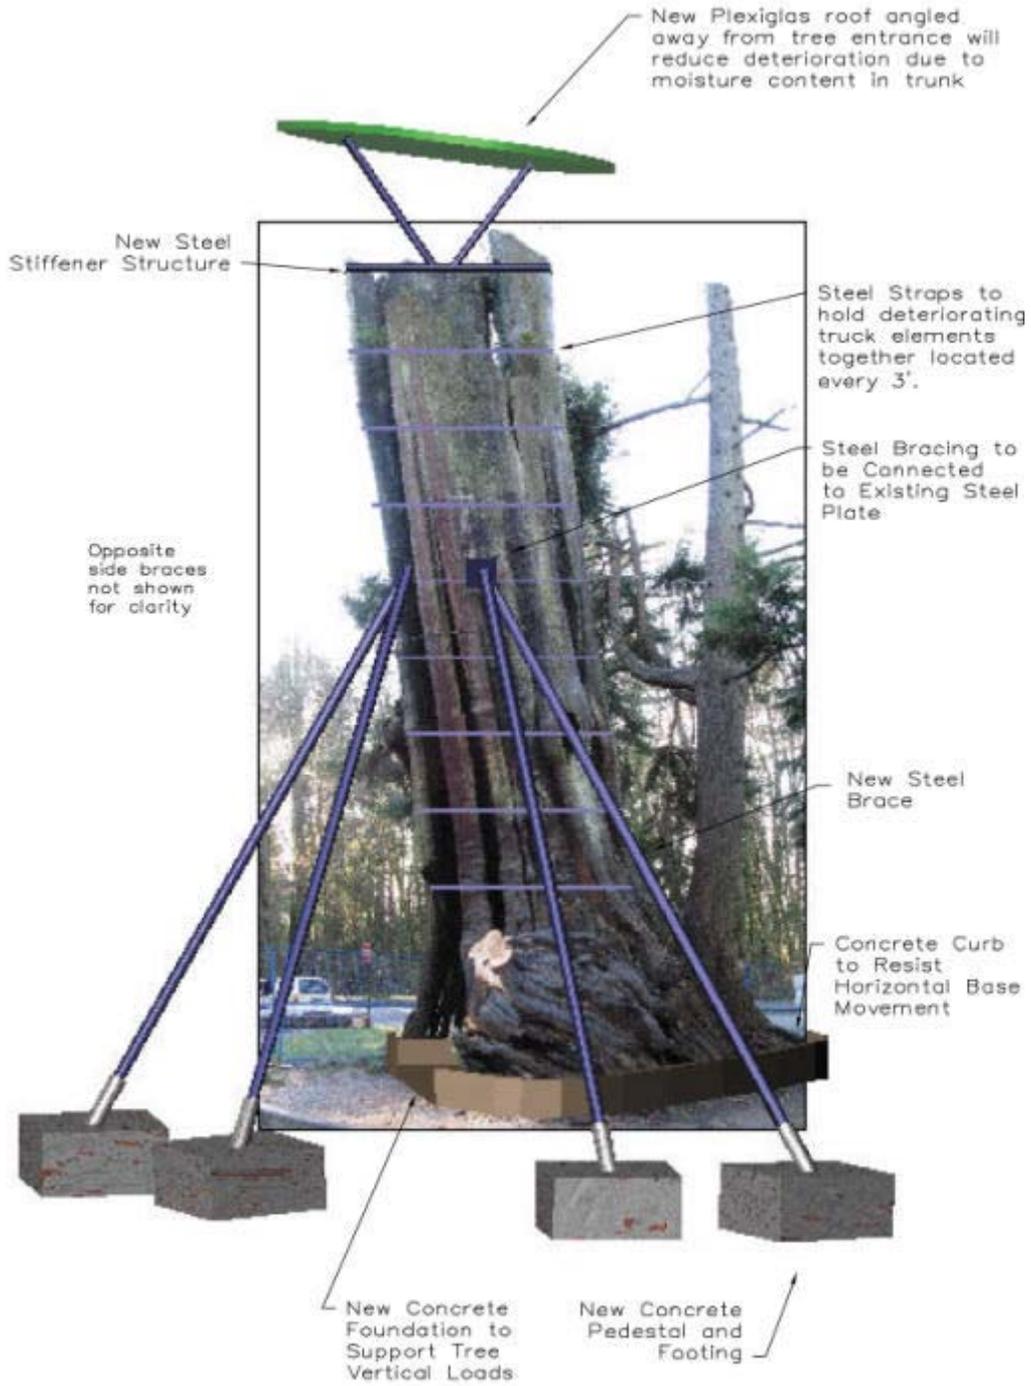
APPENDIX 1

The Hollow Tree is actually a dead snag and has been for a long time. The illusion of a green canopy was in fact three hemlocks which were growing out of the deadwood in the cedar root flair. The eastern half of the root flair has rotted away, resulting in the 11-degree lean of this 13 meter snag. Early photos show the tree standing erect. The trunk is also vertically cracked and in some places separated; akin to the staves of a barrel. Cabling, bolts and braces have been added over the past 30 years to keep the trunk together.

The winter storms of 2006/2007 not only downed thousands of living trees but also caused the Hollow Tree to further splinter and lean. As a result, staff monitored the tree throughout 2007 to watch for further deterioration. The storms of last winter resulted in further cracking, and staff determined that the snag had become a safety risk to the public. The area around the snag has been fenced off, and a structural engineering firm was retained to assess the possibility of saving the “Hollow Tree.” The recommendation was for a series of large external steel braces to counter act the 11-degree lean. To internally brace the tree would require attempting to return the snag to a vertical position. This would require cutting the remaining roots and an artificial build-up of the missing root flair on the east side. Because of the barrel stave nature of the trunk, there is a high probability it would break apart without numerous significant steel collars, inside and out. Even with these efforts, there is no assurance of success.

Hollow Tree with External Steel Braces

Hence, the external steel braces (APPENDIX 1) are the only reasonably certain solution. However, they will ruin the aesthetics of the setting as they would be right in front of the hollow opening, discouraging family photos.

The snag will continue to deteriorate over time at an accelerated rate. Therefore, staff recommend that the snag be taken down, whole if possible, and laid as two longitudinal pieces that visitors can walk between to appreciate its size. The trunk would be cut about 200mm above the ground plane with the lower root flair becoming a symbolic planter for a new single cedar planted at its centre.
