Hollow Tree – Temporary Bracing Method Statement

Stanley Park
Vancouver, BC

Temporary Stabilization Report

Prepared for: Hollow Tree Committee

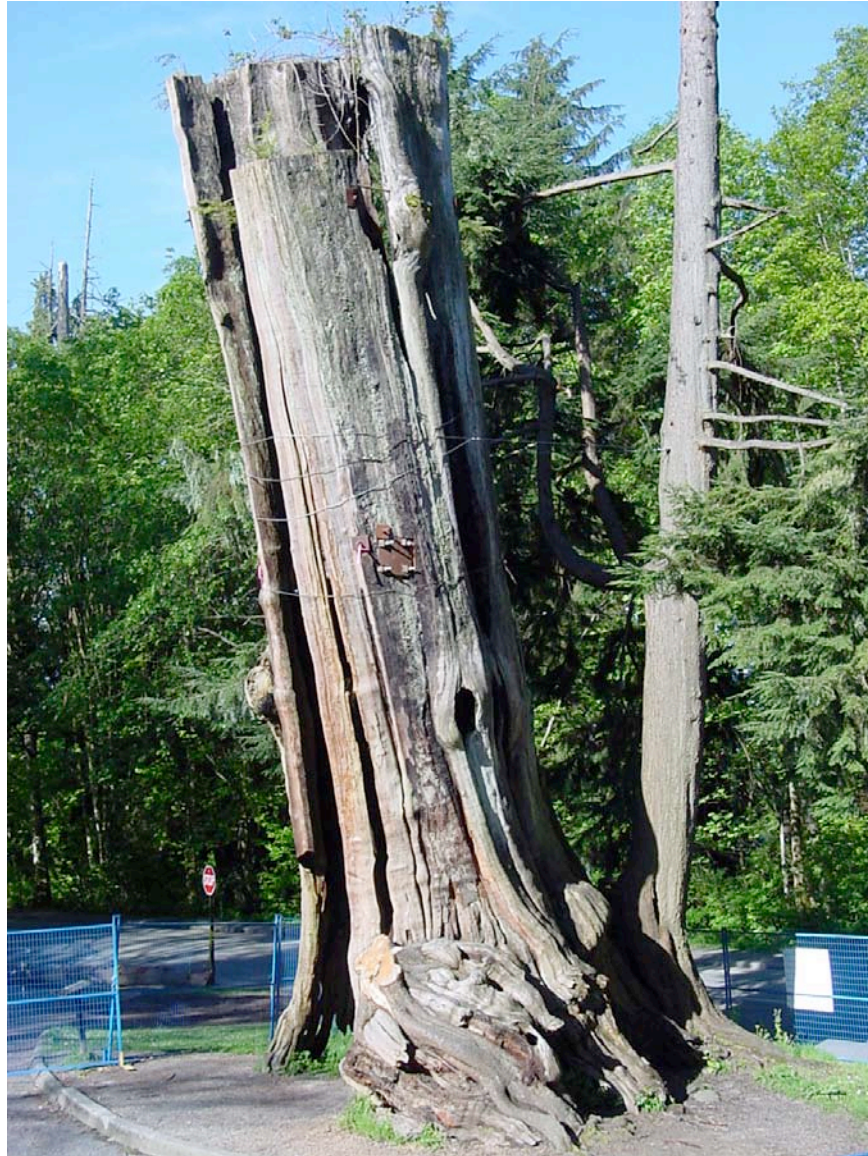
Figure 1. Overview of Hollow Tree prior to stabilization. (RC June 2008)

Figure 1 above shows Hollow Tree before the stabilization efforts described here. Viewed from the NE, the wrapping cables and one plate from the mid-span internal support can be seen. Not well seen are 2 cables from the hollow stump to the nursed hemlock tree to the West. Out of the frame of the picture the hemlock has been topped and decayed. The arborist Dr. Dunster confirms that the hemlock is not healthy itself and endangers the Hollow Tree with its presence in several ways. The blue security fence was put up by Vancouver Parks to shut off the parking area and keep visitors at a safe distance should the tree fall on its own or during a storm.

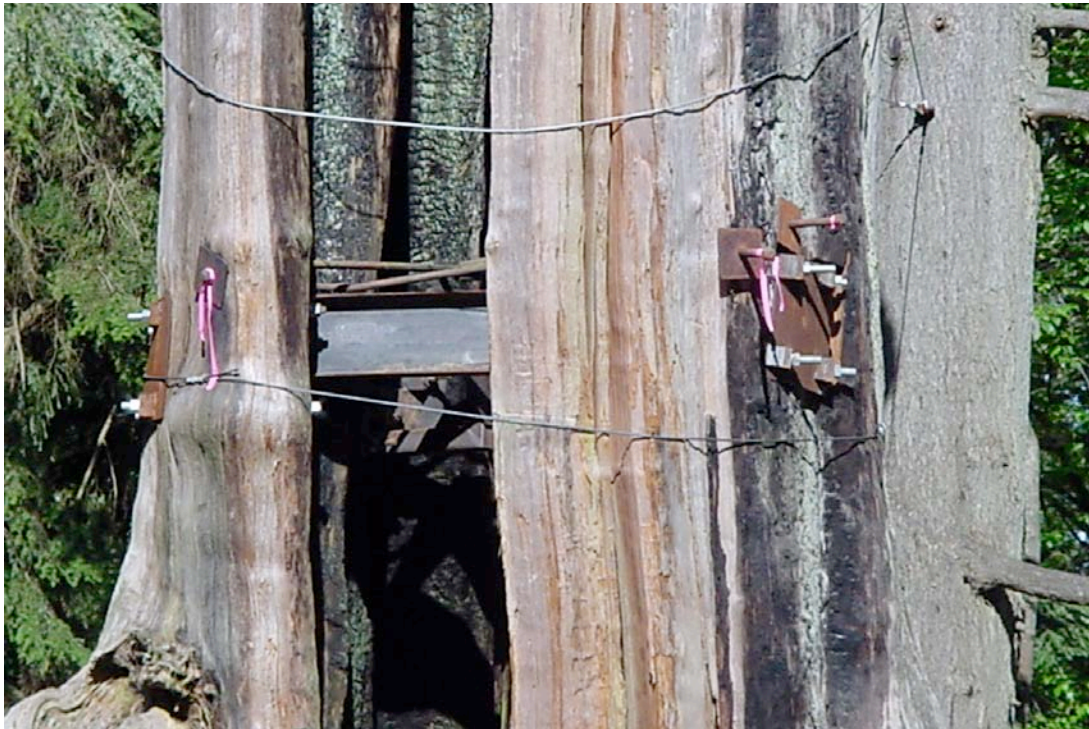
Figure 2 below shows the internal steel framework installed previously to retain the roughly cylindrical shape. The stump has split lengthwise several times so wire cables were wrapped around the tree to maintain relative position of the various parts and try to maintain some structural integrity to the whole. These measures did maintain almost all of the original tree material which is admirable from a conservation point of view. The thru bolt holes and some wood removal to flatten locations of bearing plates are the only loss of artifact fabric.

Figure 2. Mid-span steel internal support structure. (RC June 2008)

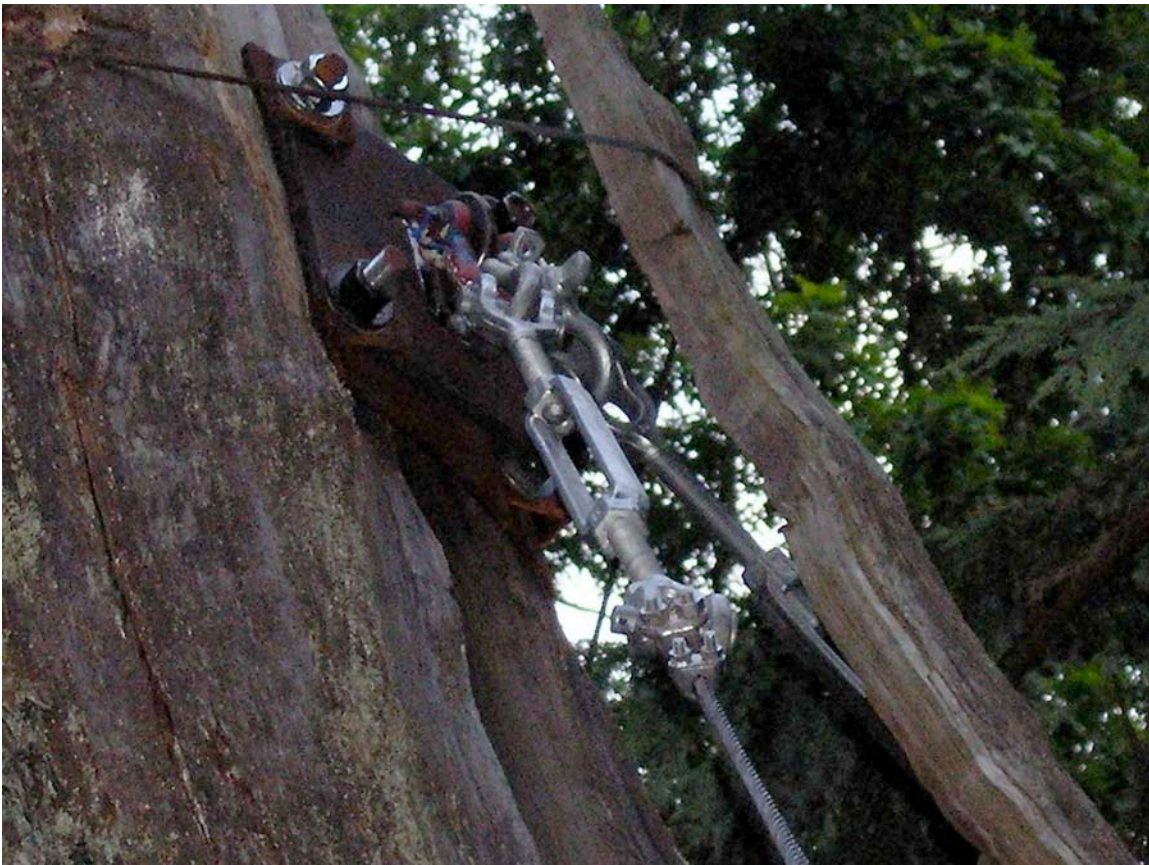
Figure 3 below shows the top of the cables attached to the west side of Hollow Tree. A 12" x 12" plate was already in place as part of the mid-height internal steel structure. A new plate was added with mounting for clevis to which was attached 2 turn buckle units (1"). Cables of 3/8" diameter were used with an eye formed (thimble plus 3 clamps) at the turn buckle. The other end of cable was passed below two (2) lock blocks buried in the ground directly beside road bed. The free end was wrapped around block and secured to standing line with 3 clamps. The threads on these clamps were crimped to prevent accidental loosening. With installation of all the components the turn buckles were tightened until equally taut as judged by hand. The purpose of these cables is to prevent sideways movement of the stump during winds or storms.

Figure 3. Cables attached to west side of tree. (RAC July 25, 2008)

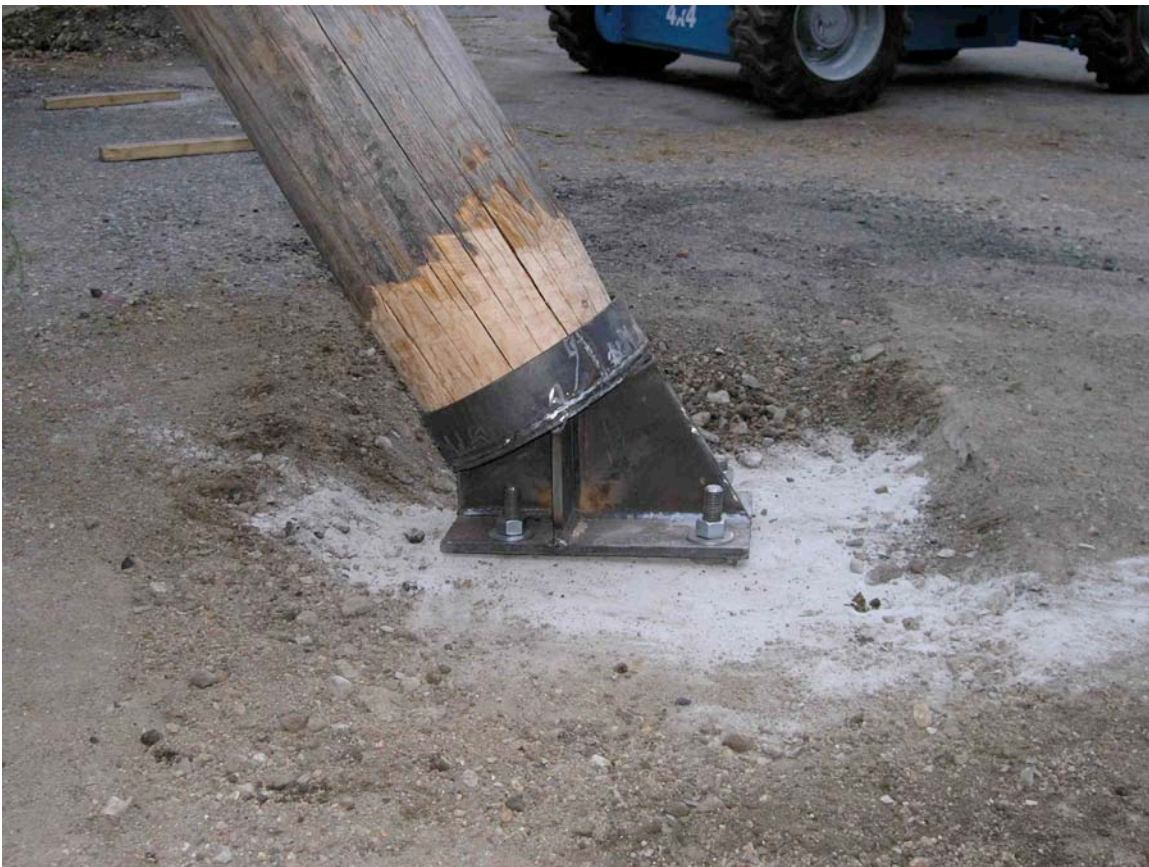
The base plates for the north and south struts set on lock blocks buried in the ground. Both of these are located in the paved parking area so the ground is very compacted and the material is gravel. The lock blocks are 30" x 30" x 60" and weigh approximately 4400 lbs (2,000 kg). Specifications call for the line of force down the brace to hit the blocks as close to the front of the block as practical (to still get 4 bolts securely fastened to the blocks). Figure 4 shows the south strut base plate on the lock block. The blocks were leveled and backfilled with compaction. The base plate is secured to the log strut with 4 epoxied rebar pins 12" long that are welded to the plate. To allow for water draining away from wood end grain, a 1" hole was cut at the low point in the collar. The anchor bolts are 1" x 12" and epoxied to the lock block with Simpson AT-13 quick set epoxy.

Figure 4. Base plate for south strut. (RAC July 25, 2008)

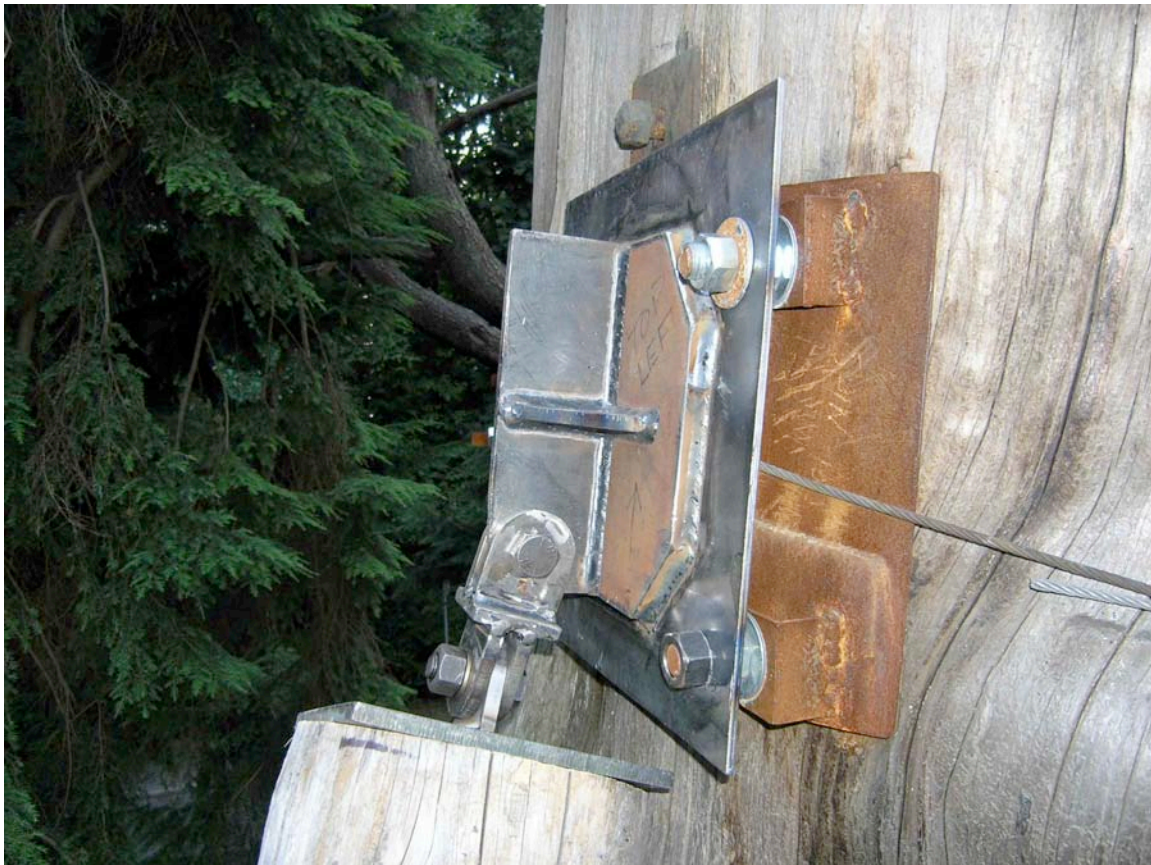
The strut top end joint was designed as a universal to ease installation and give options to the final solution methodology, Figure 5. With this joint these temporary struts can be used to ‘push’ the tree upright later, if that is the preferred solution. The thinner backup plate was an on site fix because the original plate (size estimated from pictures only) was not large enough to catch the 4 thru bolts. For this south side bracket the new plate is square to the existing plate and to the 4 bolts. Tightening the nuts brought all corners of the bracket into hard contact with the nuts left on for the internal support structure. The log strut is secured to the bracket with 4 rebar pins 12” long and epoxied into the log end with Simpson AT-13 quick set epoxy. None of the top or foot brackets are painted nor galvanized because of the short expected life of their placement. Also shown in this picture is one of the ¼” cables pulled around the circumference to hold the various pieces of the tree in relative position.

Figure 5. South strut top end universal bracket. (RAC July 25, 2008)

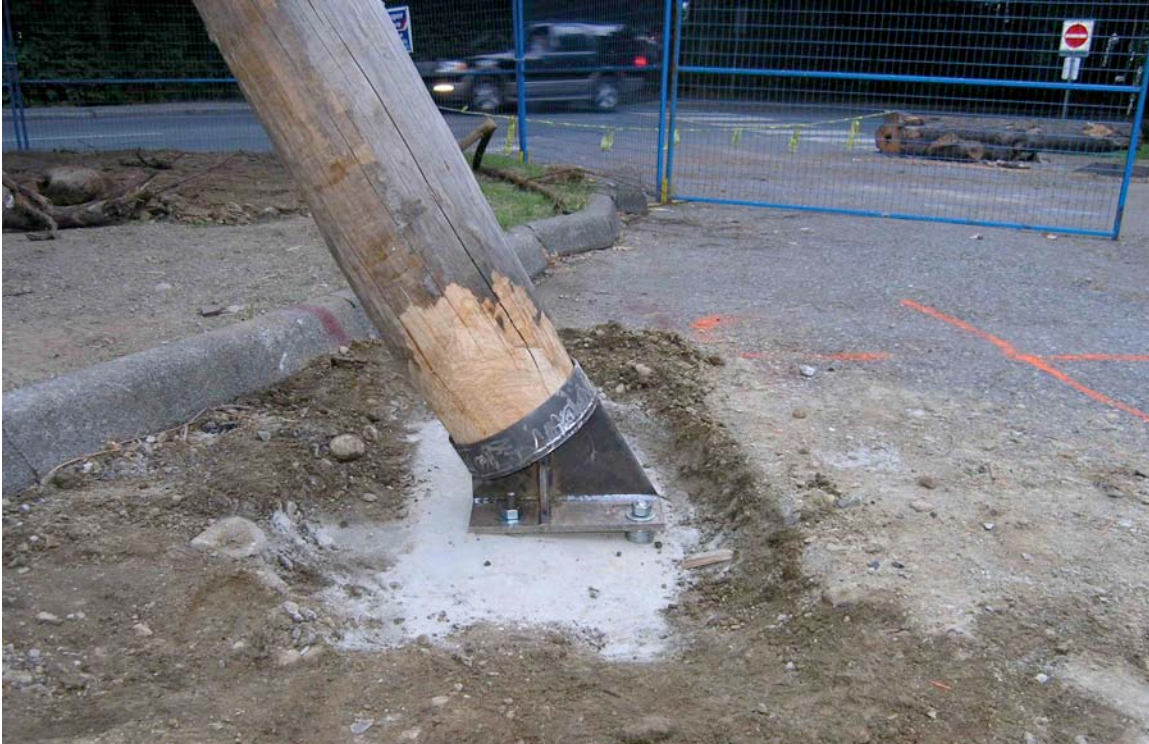
Exactly similar to the base plate for the south strut, the north strut is shown in Figure 6. The bottom plate was not as carefully aligned with the axis of the log resulting in the need for spacers to be used on the outer 2 anchor bolts. Note, the plate length is 16” and the block width is 30”.

Figure 6. Base plate of north strut. (RAC July 25, 2008)

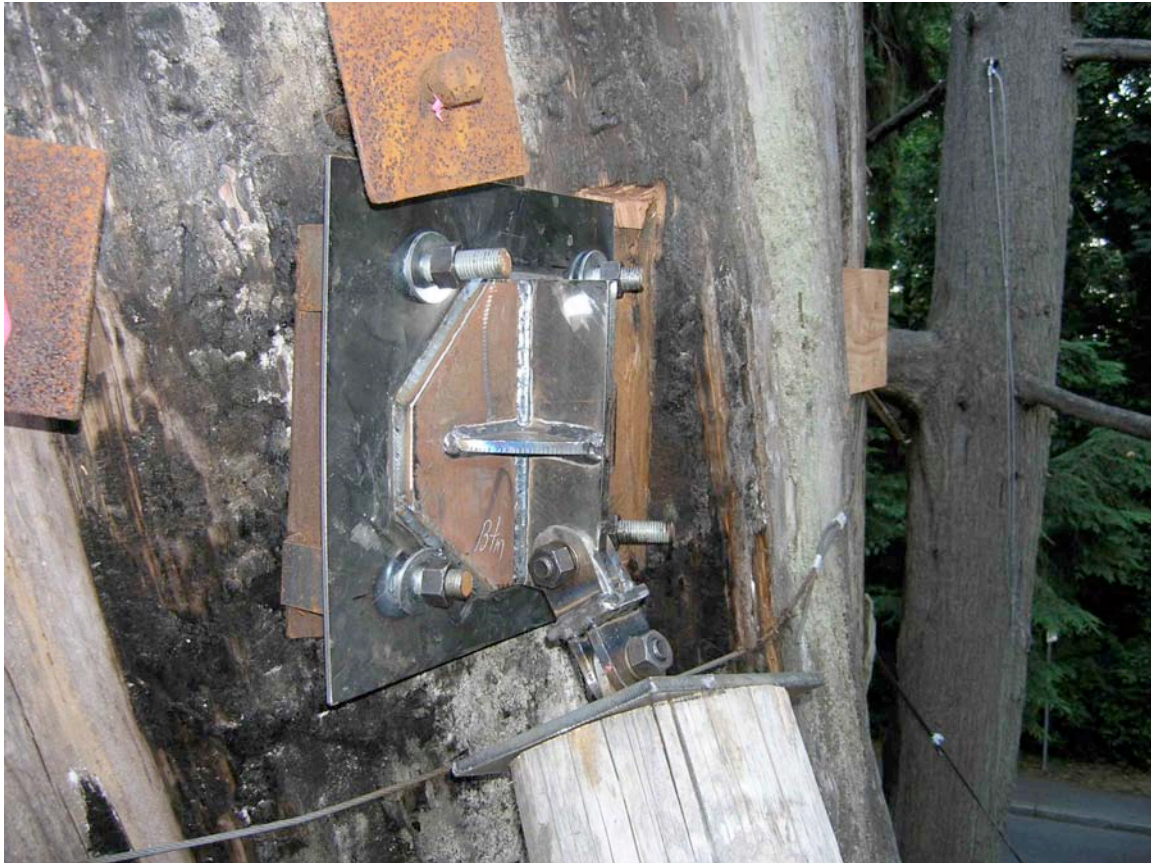
As with the strut on the south, the north strut top end bracket is a universal joint and modified on site with the ¼” backing plate, Figure 7. In this case the 4 thru bolts are not perpendicular to the plane of the plates so the washers and nuts do not engage fully. To make the alignment better, the two far nuts from the original structure were removed. The three other small plates shown are from previous stabilization attempts and are not currently engaged. In the background laying against the hemlock trunk is the cut ¼” cable that had been tied between the hemlock and the cedar stump.

Figure 7. North strut top end universal bracket. (RAC July 25, 2008)

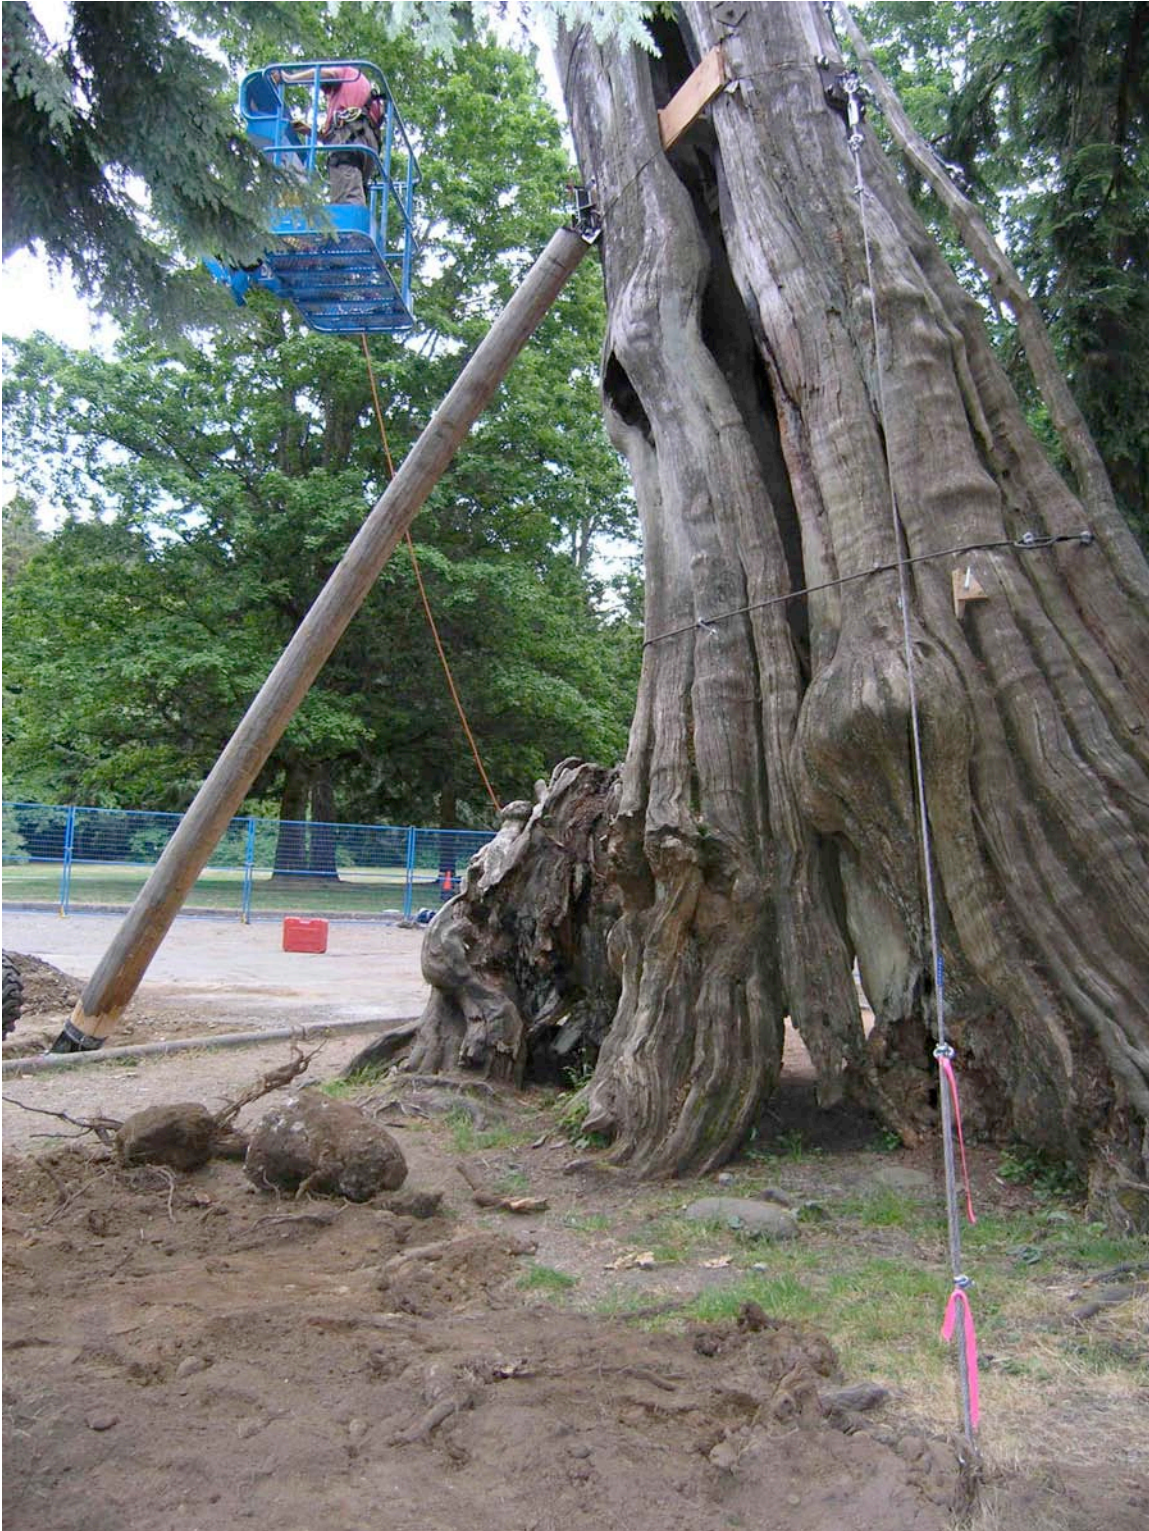
The north side of the Hollow Tree in Figure 8 shows the strut to the east and cable stay to the west. Various cables, plates, brackets, and other bits from previous stabilization efforts are left in place; these to be addressed by the Conservation Plan. Figure 9 shows the Tree from the east with its new standing logs struts.

Figure 8. North side of Hollow Tree showing strut & cable. (RAC July 25, 2008)

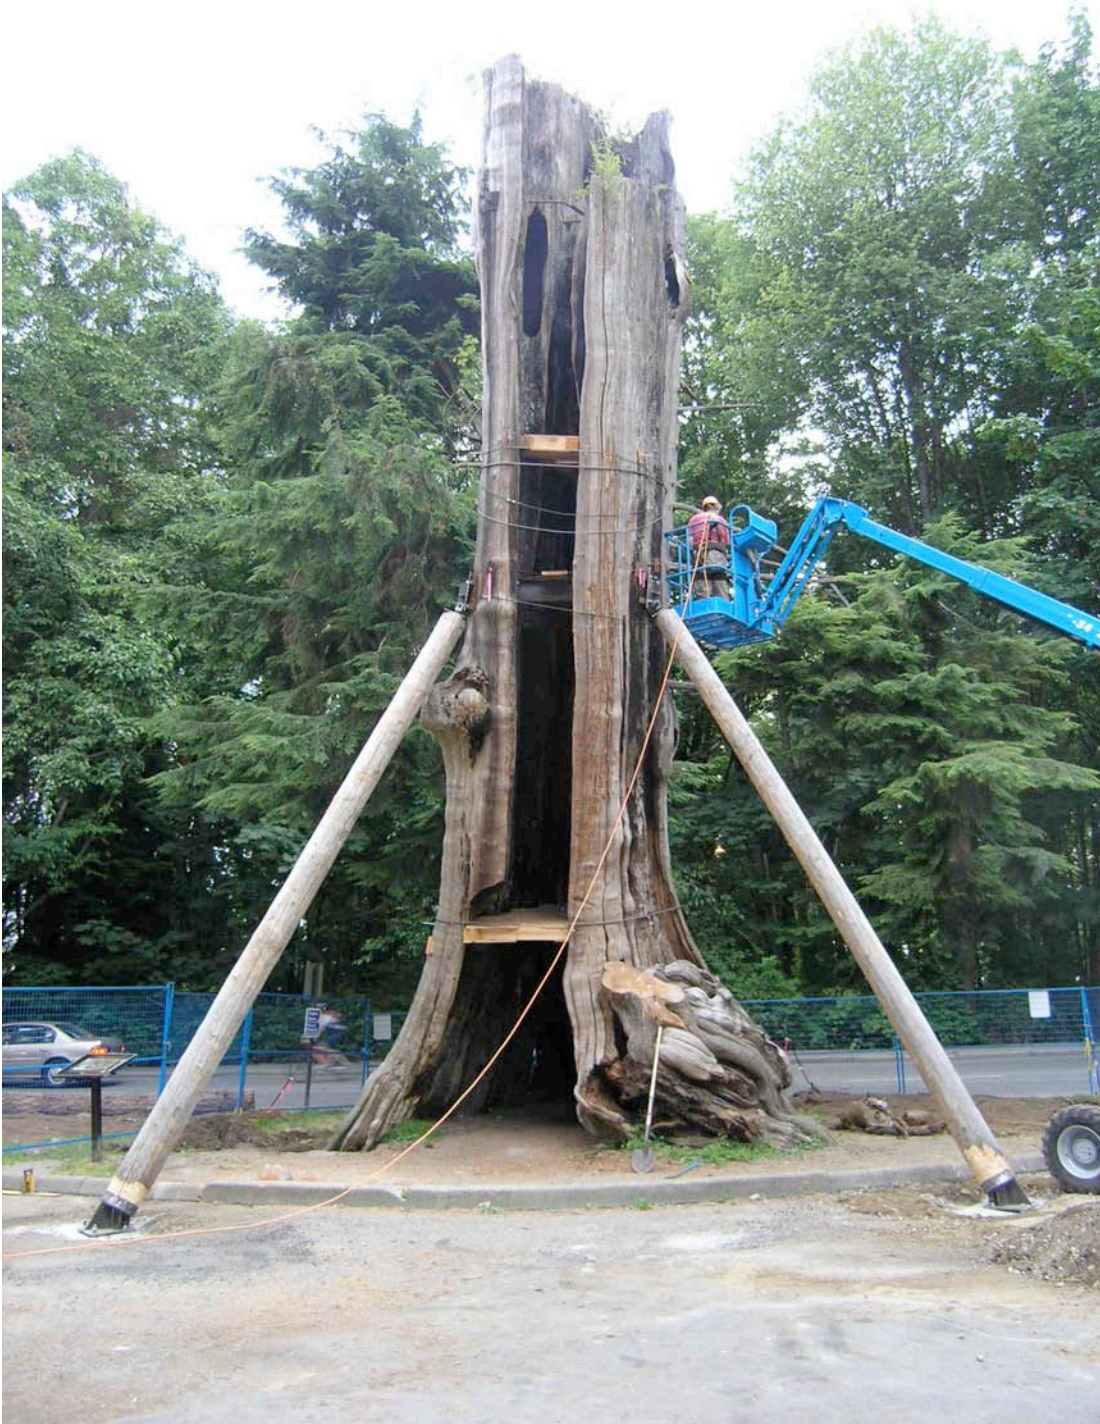
Figure 9. View of stabilized Hollow Tree from east showing two (2) struts and two (2) cables. (RC July 25, 2008)
