# STRUCTURAL ASSESSMENT

## THE HOLLOW TREE STANLEY PARK

CLIENT  
**VANCOUVER PARKS & RECREATION**

7 March 2008

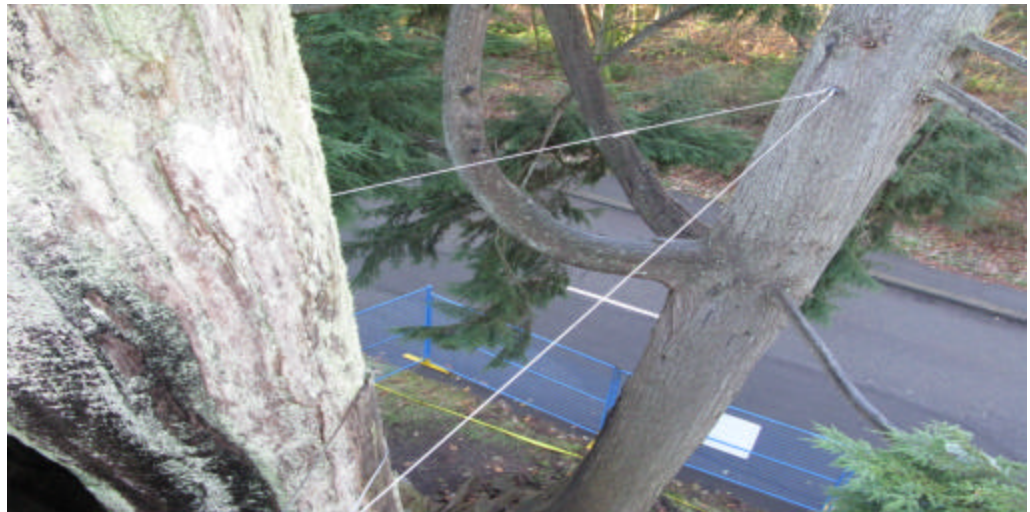
**Photo 1: Hollow Tree temporarily tied back to hemlock trunk**

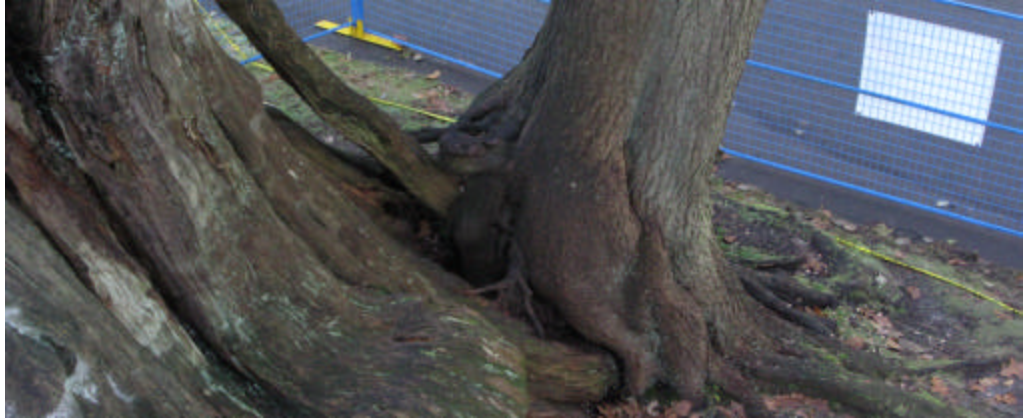
**Photo 2: Hemlock trunk rooted to base of the Hollow Tree**

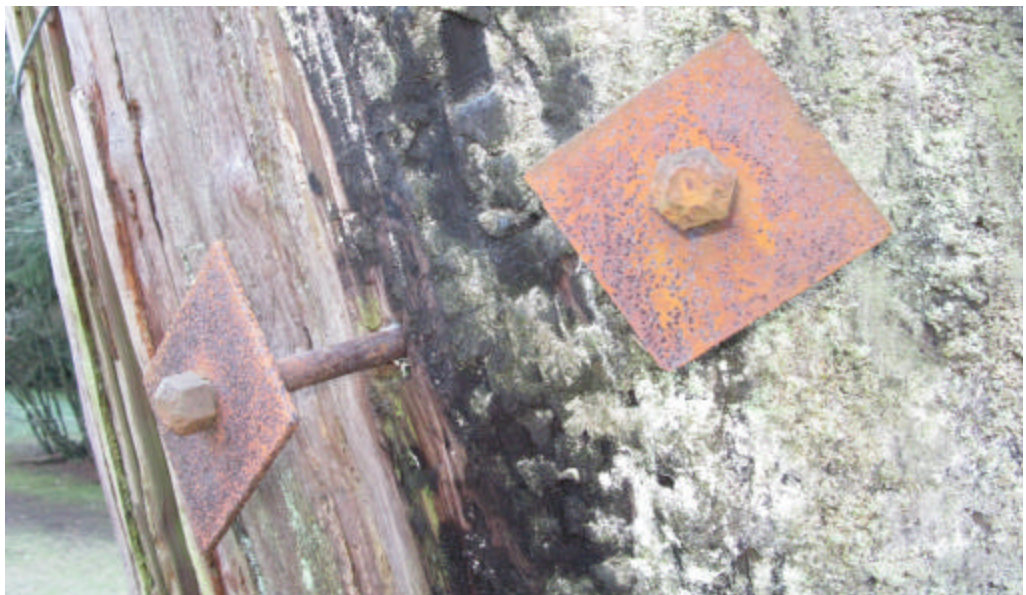
**Photo 3: Steel washers and bolts no longer effective**

Portions of the trunk have been wrapped with steel cables in an attempt to prevent portions of the trunk from buckling outwards. Several steel rods driven through the tree at mid height and near the top of the trunk some years ago are no longer effective as the steel washer plates are no longer in contact with the trunk.

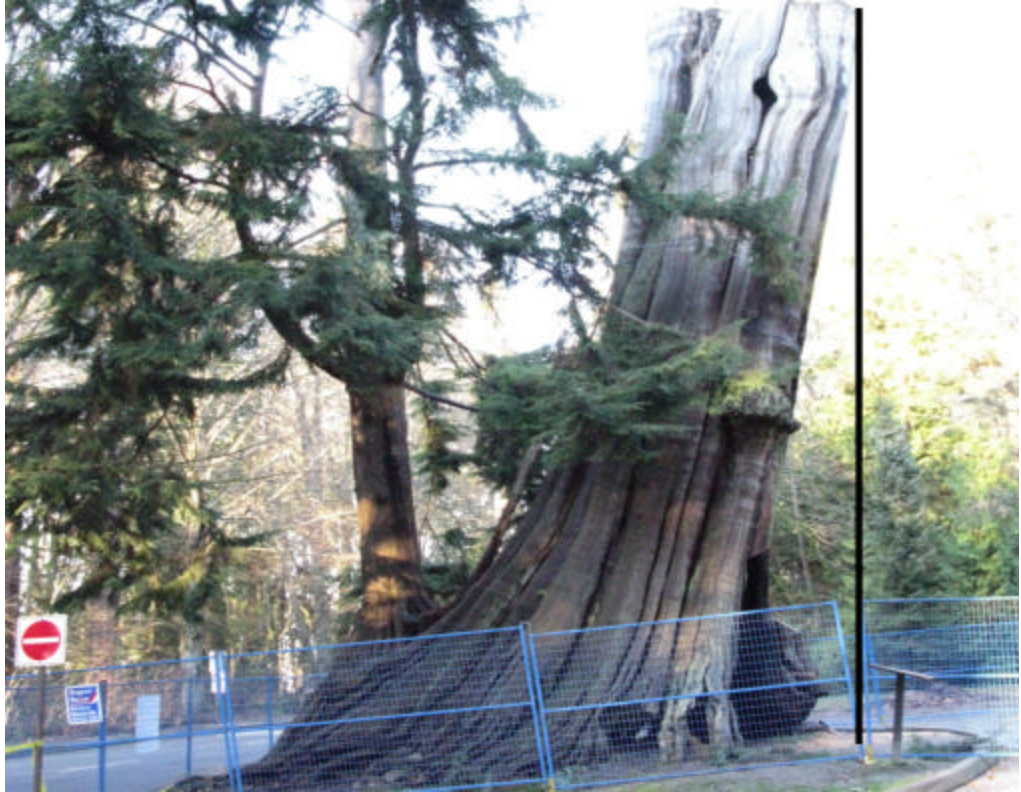
**Photo 4: Hollow Tree leaning 11° to the east**

The Hollow Tree is structurally unstable due to its present lean, its poor condition and the lack of competent root structure at the base of the trunk. The support of the Hollow Tree at the base of the trunk is tenuous with much of the trunk no longer in contact with the ground or severely decayed. The Hollow Tree is likely to sustain further damage and fall over if left in its present state.

- 6.4** Although the Hollow Tree can be structurally braced and reinforcing as proposed in Option A, we do not believe that this represents a safe and cost effective long term solution. We therefore recommend that no further structural repairs be carried out to the Hollow Tree and that the Hollow Tree be taken down.

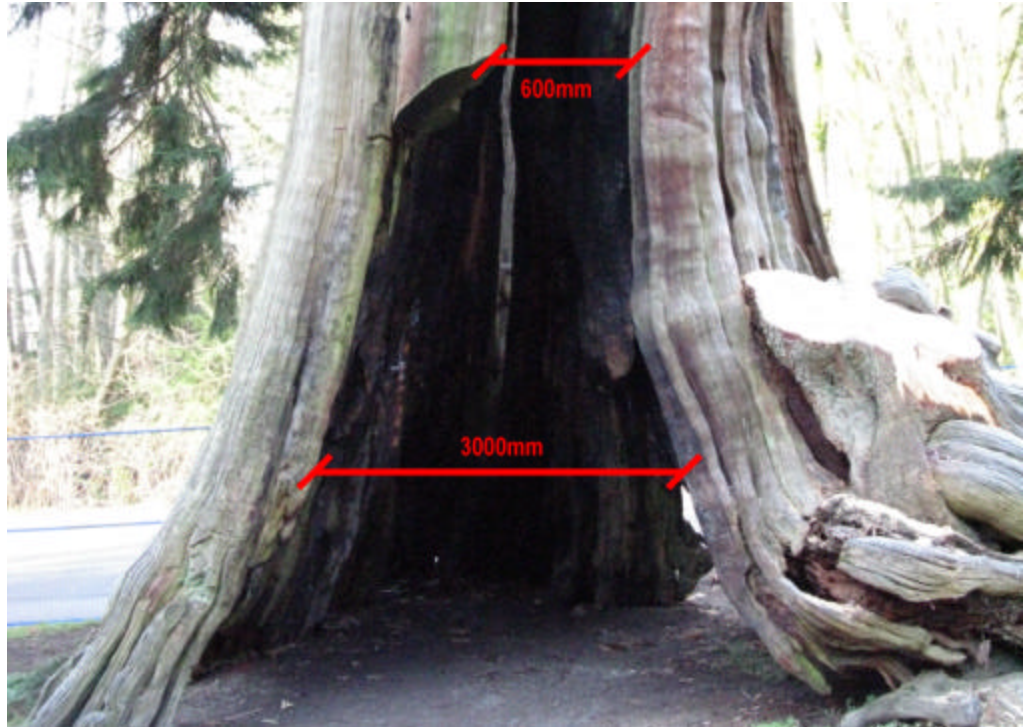
The structural integrity of the Hollow Tree is poor due to its present configuration and extent of deterioration. The tree is hollow through its full height and resembles a "C" shape in cross section due to a wide gap (varying between 3000 mm at the base to 600 mm at the top) at the east face of the tree. There are several deep vertical splits running up the face of the tree. Several of the splits penetrate the full thickness of the face, which varies in thickness between 400 mm to 600 mm. The wide gap and vertical splits have significantly weakened the tree and give rise to the potential for the tree to collapse in on itself. In addition, the tree is deteriorating with wood decay occurring throughout the tree due to exposure to weather and moisture. The bark of the tree is soft and loose with portions of the bark readily removed by hand.

Photo 5: Wide gap at east face of Hollow Tree

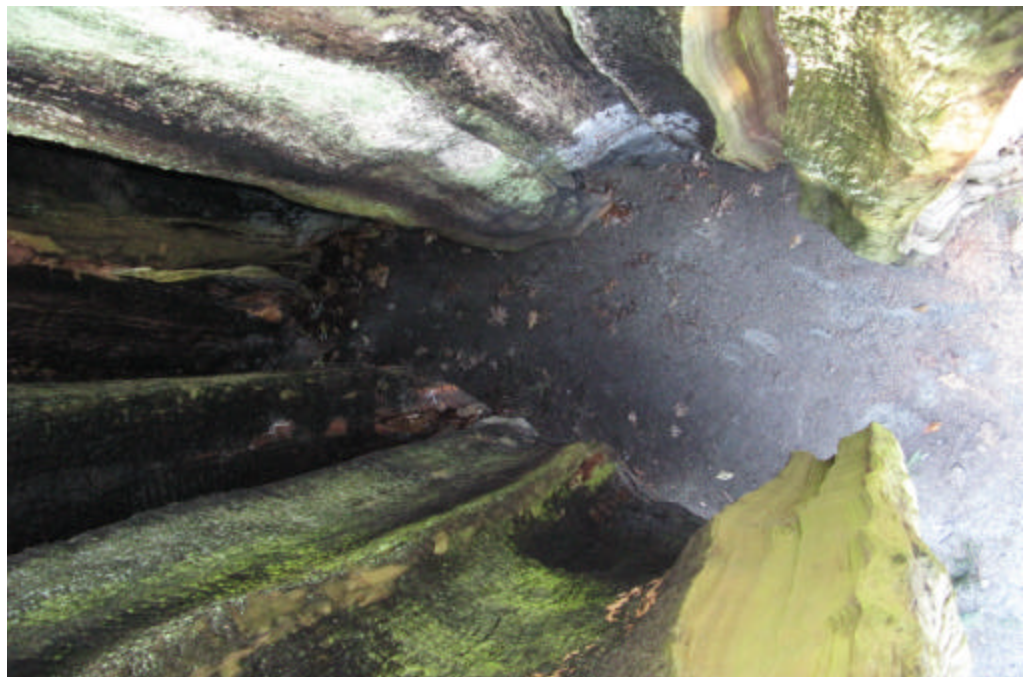
Photo 6: Looking down centre of Hollow Tree at weakened "C" shaped cross section

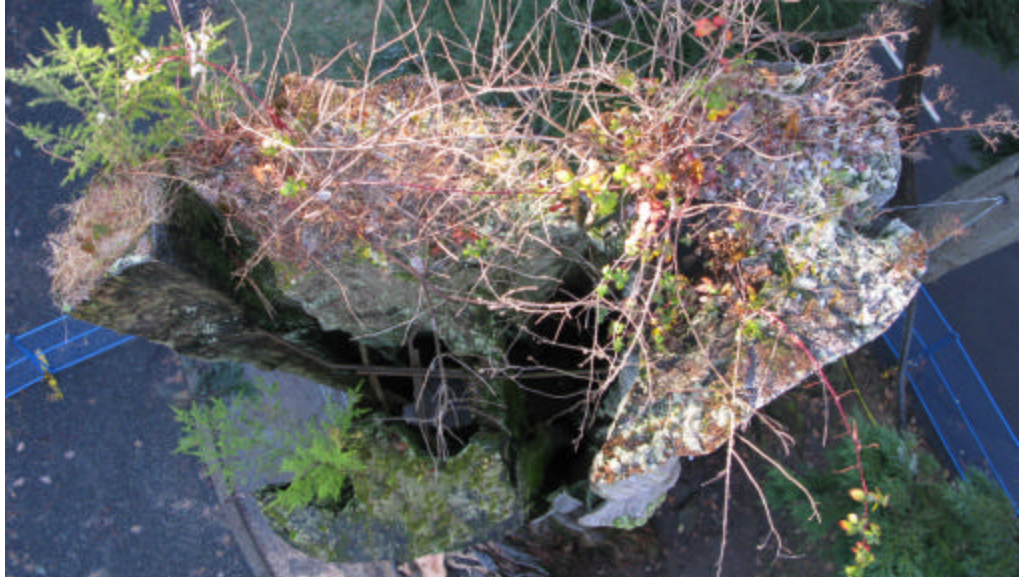
**Photo 7: Top of trunk showing decay of exposed end grain**
