Arborist Assessment Memo

Stanley Park, Vancouver

December 5, 2024

Re: Stanley Park ISA Level 1 Assessment - Arborist Memorandum

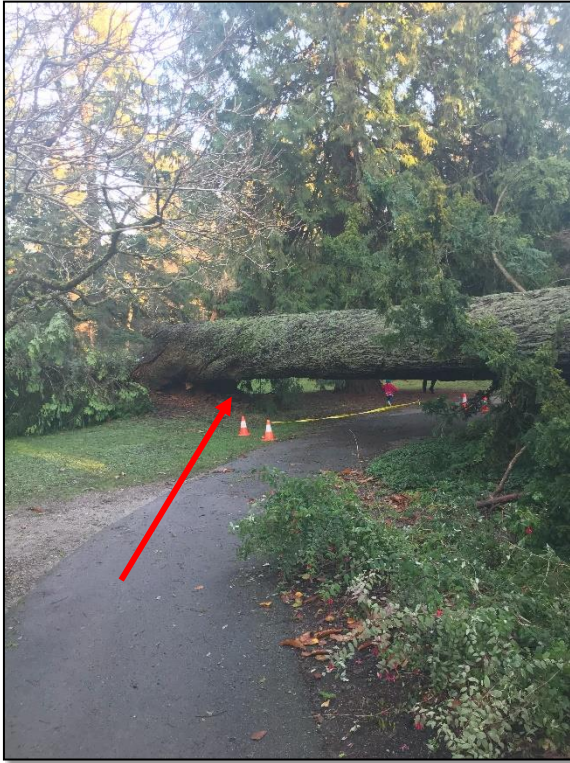
This large tree, approximately 275cm in diameter, failed during the recent ‘bomb cyclone’ storm. The tree had significant internal decay with a collar of approximately 10 cm of solid wood. It fell in a southerly direction and is now bridging across the pathway and it is approximately 5ft above the pathway. The log is still attached to the stump on the south side.

Douglas fir over pathway
(Arrows in above photos indicate the suggested location of temporary support lock blocks)

- Trim the splinters on the stump
- Install concrete lock blocks under the log at the stump end to support the log if it were to shift and drop
- Restrict access to the stump using snow fencing, and provide signage on fencing indicating DO NOT ENTER

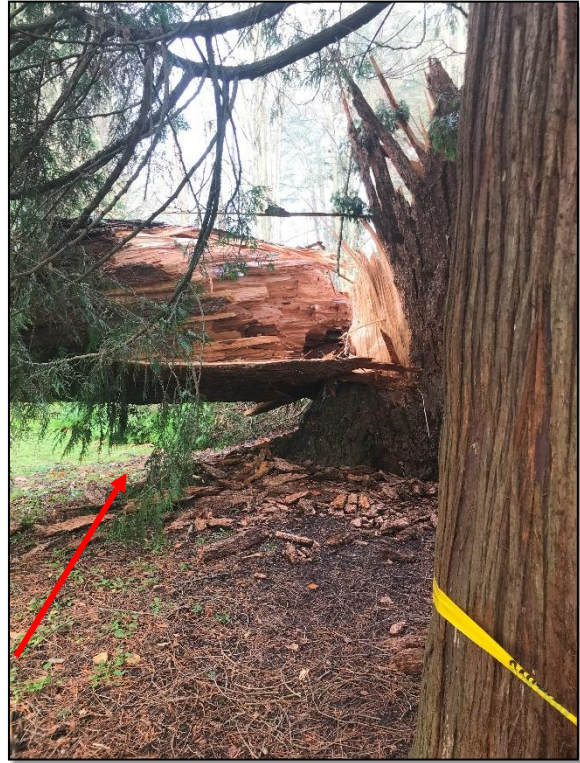
The stump splintered when the tree failed and has several jagged pieces of wood around the rim of the retained stump. Two potential hazards were identified:

Splintered stump – holding wood

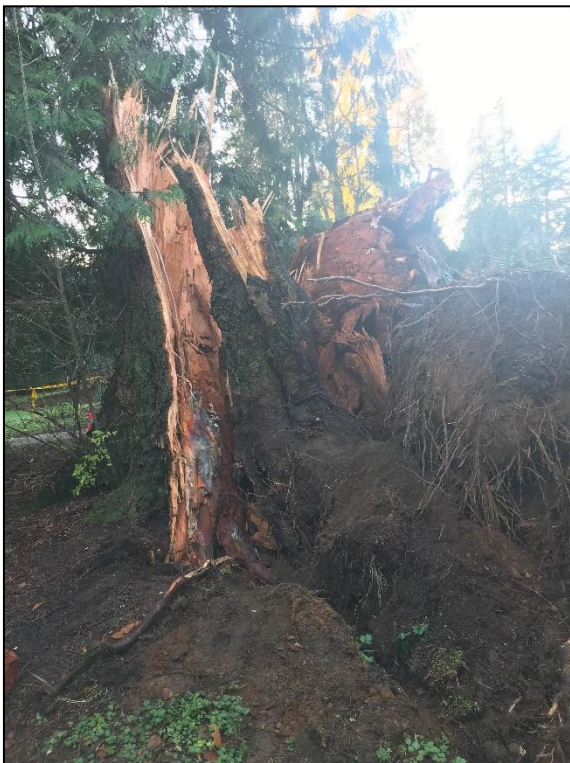
Shattered stump from north side

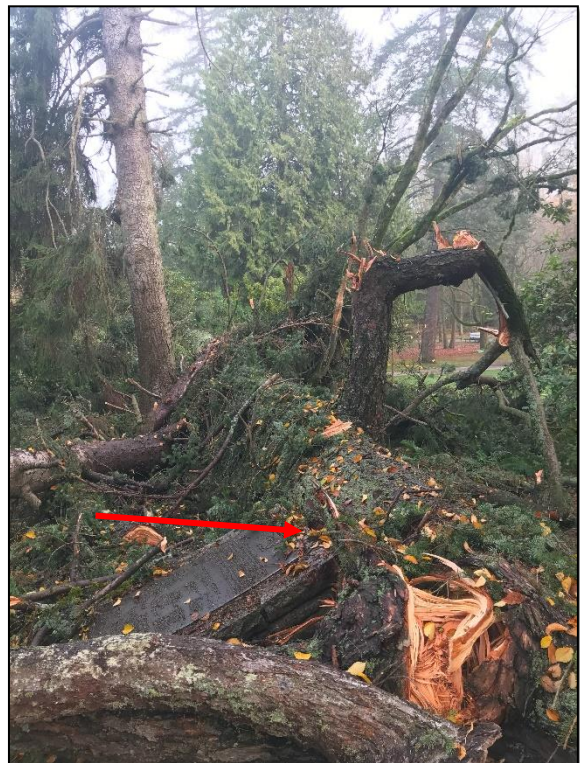
The log is sitting against a standing spruce tree and a concrete monument on the west side, and several large diameter branches (20+cm diameter) on the east side are acting as a brace preventing the log from rotating. A 40cm diameter branch is driven in the ground about ½ way along the log, supporting the centre of the log.

Top end of stem wedged against monument

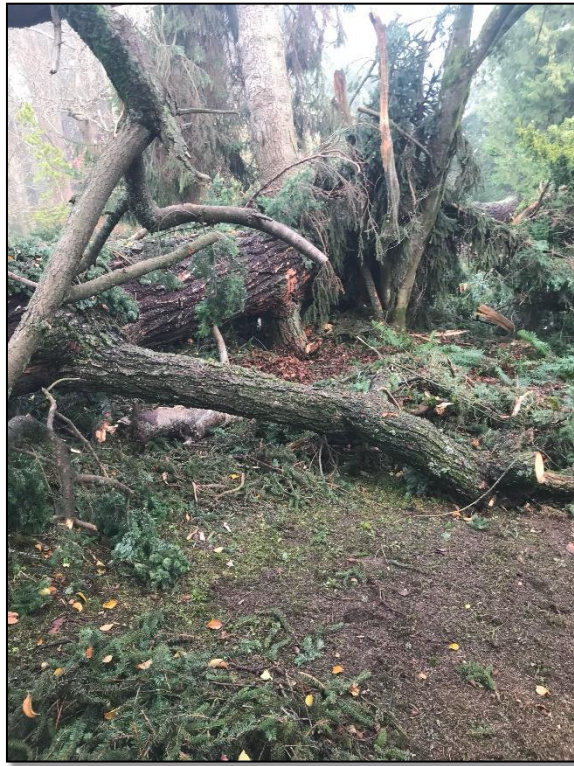
**Top of stem – Large limb providing
brace to prevent rotation**

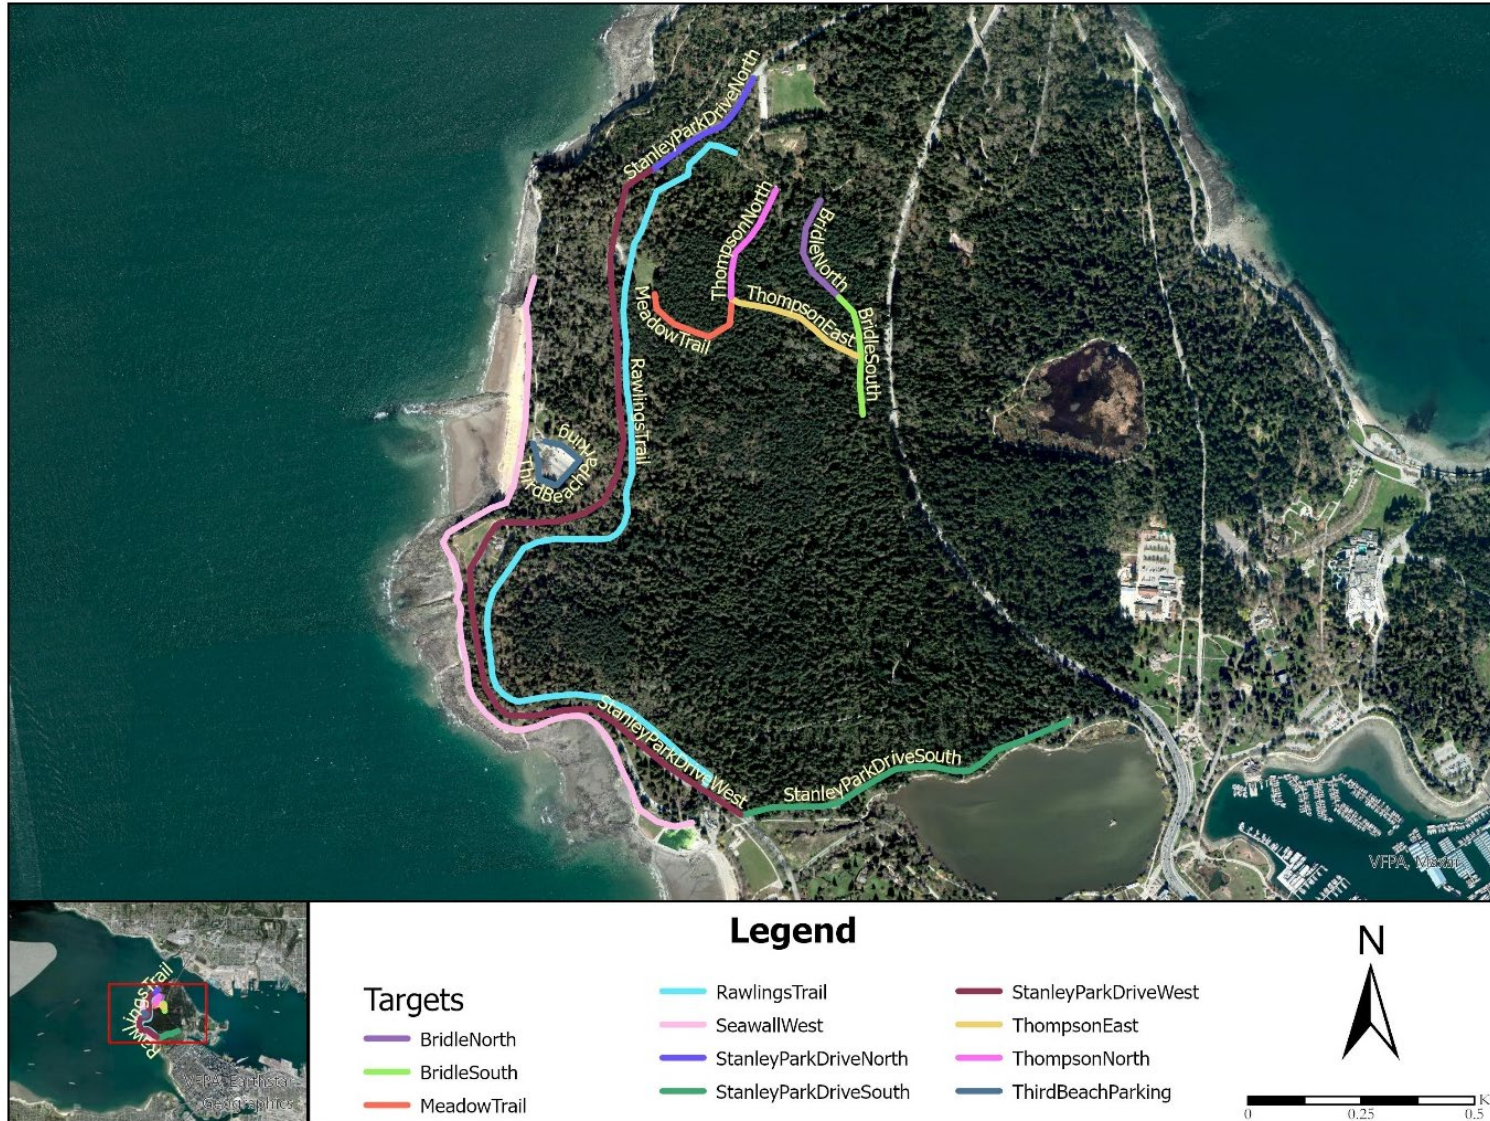
Figure 3 The targets that were assessed include the trail, road, and seawall segments highlighted in the colors above. Each of these segments corresponds to the trail names in Table 3.

The density of trees that meet the specified tree risk threshold varies across the study area. The forests with a high concentration of Western Hemlock trees, which have been affected by the Hemlock Looper outbreak, pose the greatest risk. These trees are in various stages of decline. We have identified trees that exceed the specified risk threshold and recommend that they be treated as soon as possible. Additionally, there are other trees that are either dying or have recently died. Many of these are western hemlock trees that show clear signs of decay. The likelihood of these hemlock trees failing will increase over time as decay progresses. While these other trees do not currently meet the specified risk threshold, we expect them to do so within the next two years.

A detailed, tree-by-tree assessment is necessary to properly identify, document, and mitigate hazardous trees. We recommend that the City of Vancouver establish the occupancy rates for each assessment area, adopt a risk threshold for treating hazardous trees, and carry out a more comprehensive risk assessment.

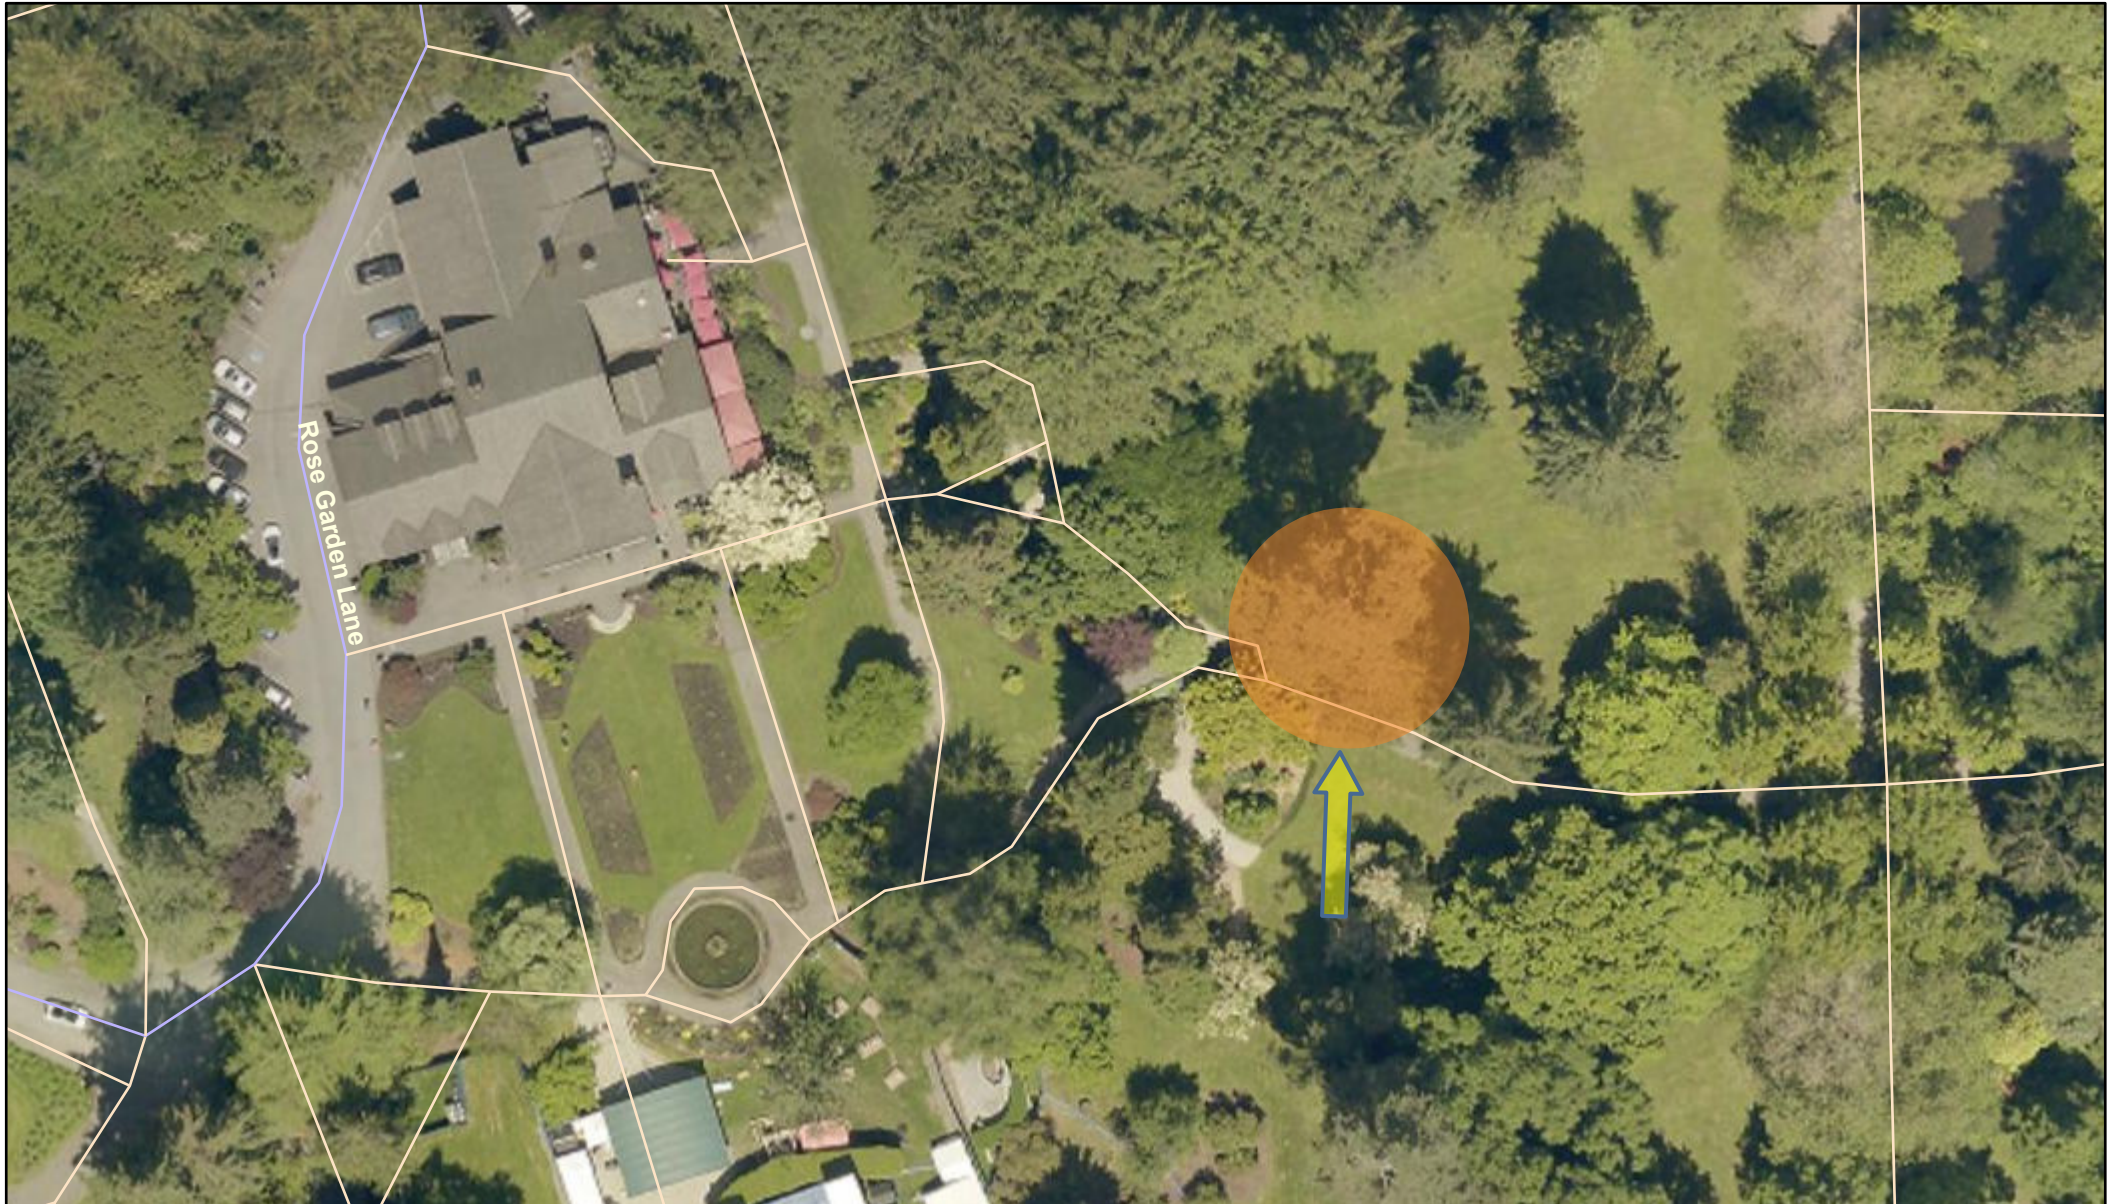
Malkin Bowl - Large Douglas Fir Failure

ISA Level 1 assessment observations were made at Malkin Bowl pertaining to the large Douglas-fir tree failure. While this tree has failed and is laying horizontal to the ground, it does appear to be held up off the ground by one of its larger branches. If the tree is not going to be removed in the short term, the area around the entire tree should be fenced off to keep the public away as it does pose an increased level of risk in its current elevated state. If the plan is to retain the tree in the longer term, the tree should be pruned of its branches so it is lying in a stable position on the ground. The stem could be removed from the site by cutting it into smaller manageable pieces; however, due to the large diameter of the stem, mechanical equipment will likely be required for removal.
