**Stanley Park Wayfinding and Signage System  
Signage Review Audit**

Karo Design Vancouver, 6 April 2004

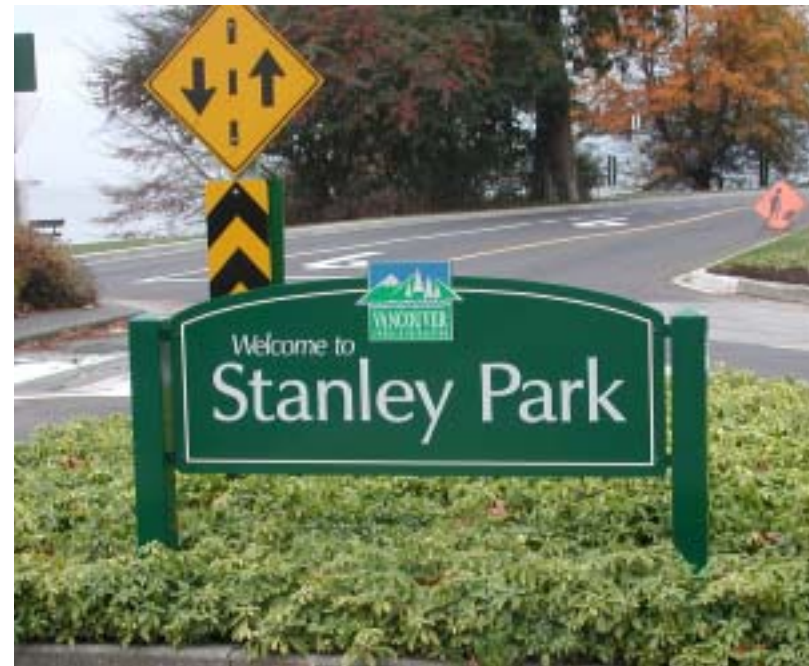
Identification Sign

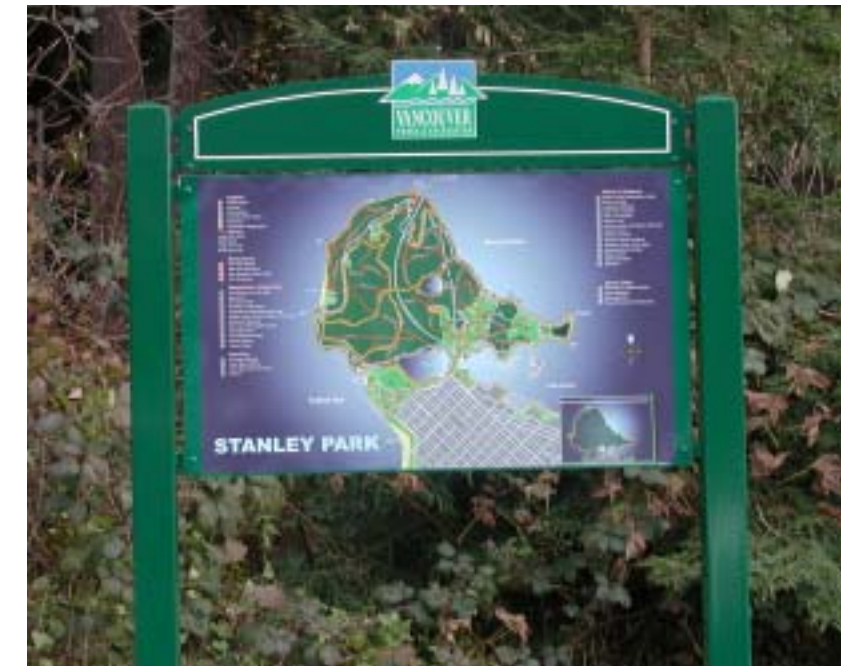
Directory.  
*Is this map easy to read and understand?*

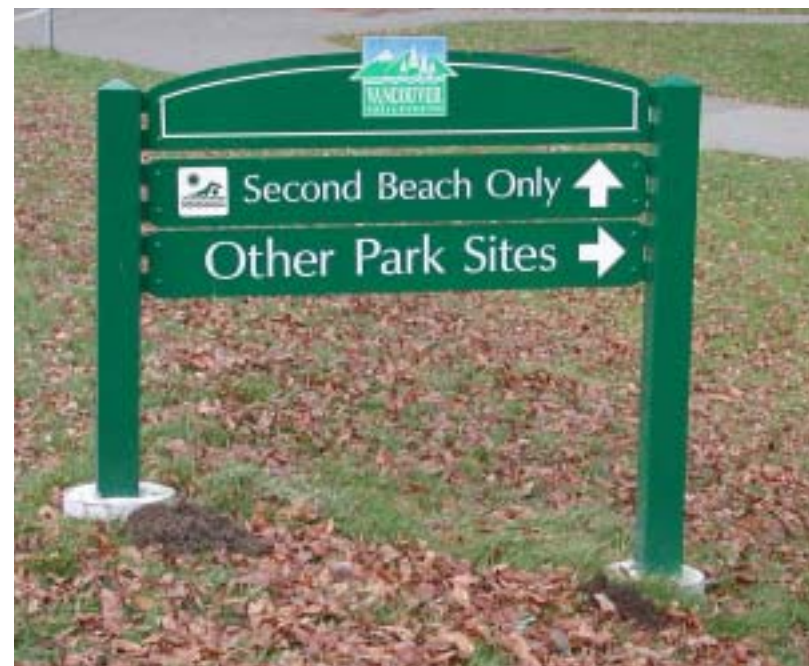
Directional Sign.  
*The directional arrows are not to international standards.*

Recommendation: Messages with arrows indicating right directions must appear on the right side of a sign. Messages with arrows indicating left directions must appear on the left side of a sign. Depending on the sign location (left or right side of road), messages directing straight ahead will be flush left (right side of road), and flush right (left side of road).

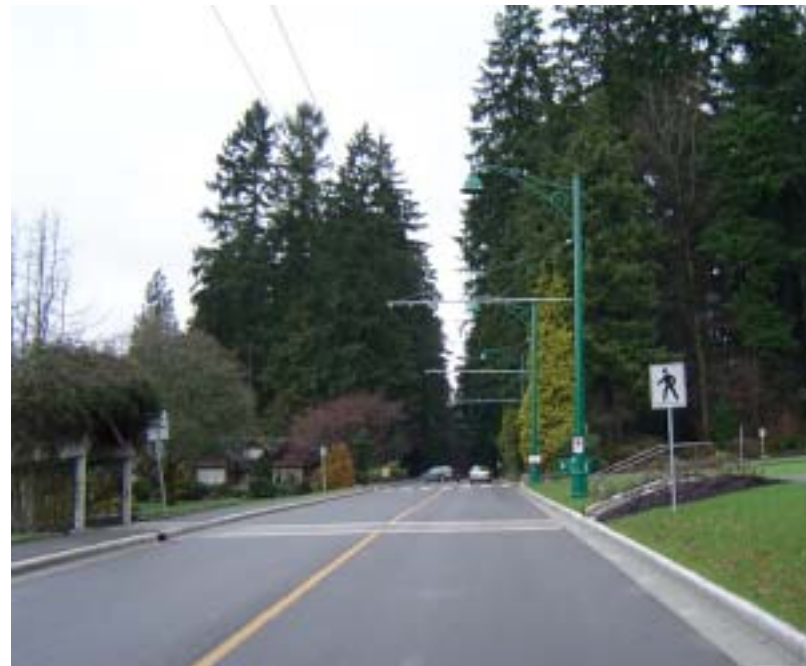
*No advanced signage indicating an approaching destination.*

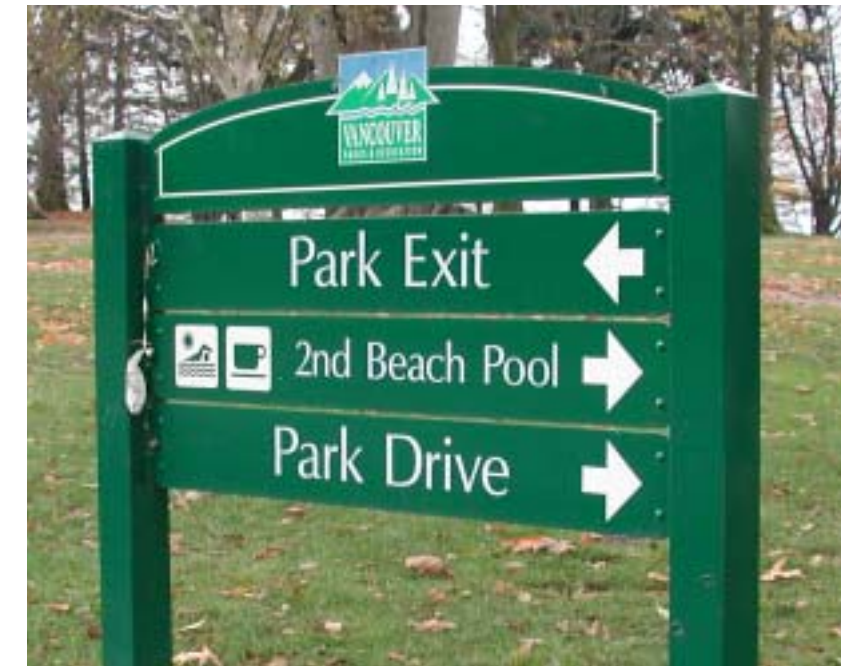
*Inconsistent type sizes.*

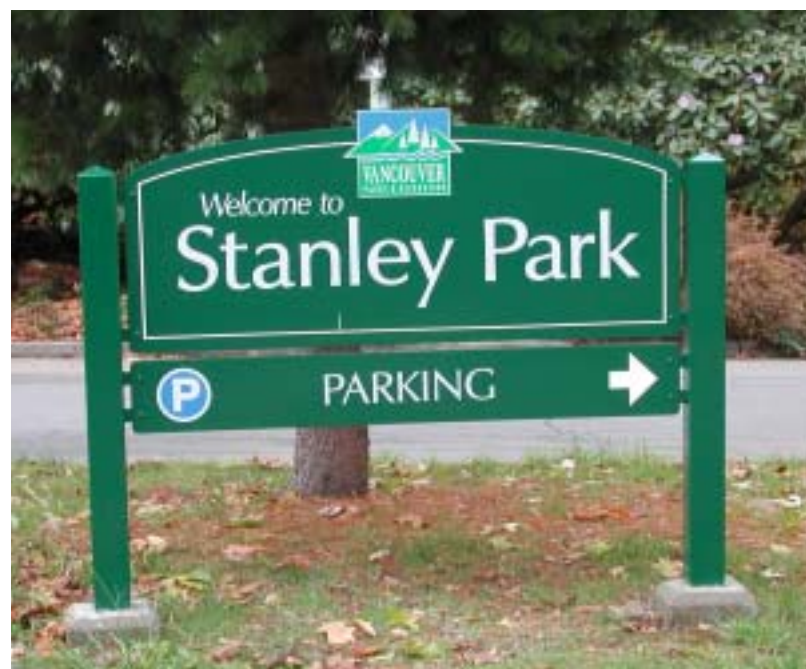
*Identification Sign (with directional sign blade).  
Potentially confusing to combine identification and directional information on a driver oriented sign?*

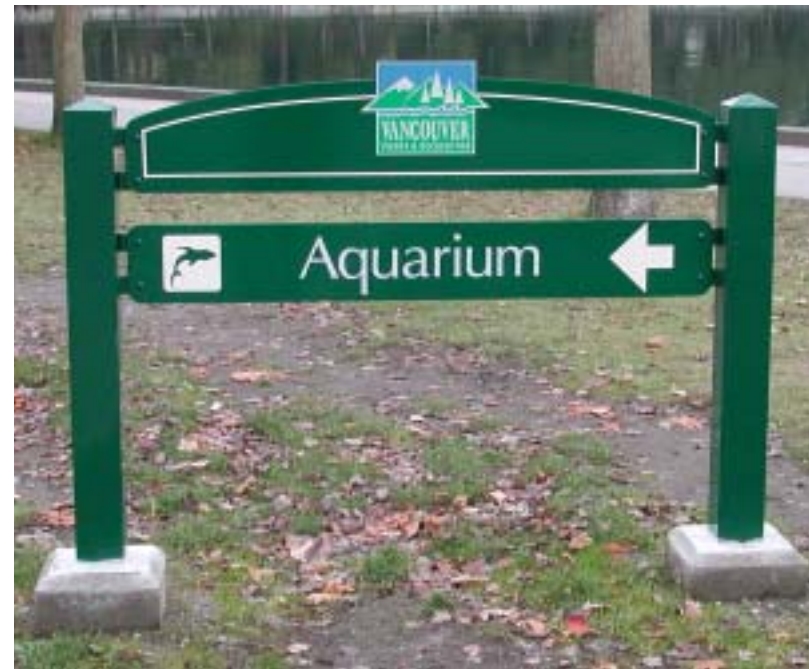
1. Current sign directly opposite the Information Centre parking lot entrance, which directs visitors into parking lot rather than to Aquarium parking.
2. Lower mounting height and visual 'height' of signs lends into the background.
3. Installed under a tree, in shadow and hard to see. Signage can be camouflaged by foliage and leaves.

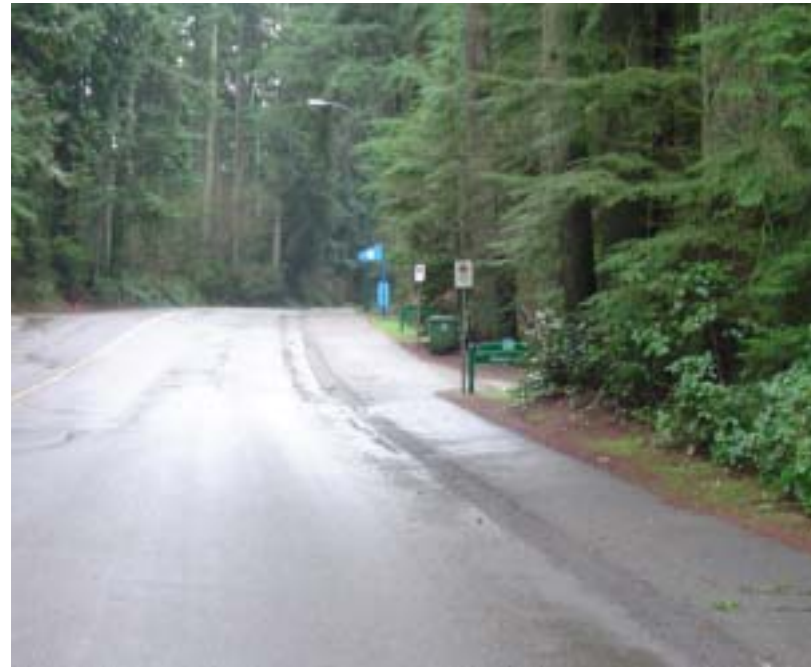
5. Signage obscured by foliage and garbage receptacle.
6. Signage obscured by lamp post and stairs.
7. Low shoulder installation obscure sign.
8. Signage installed on road curve and low shoulder is difficult to see.

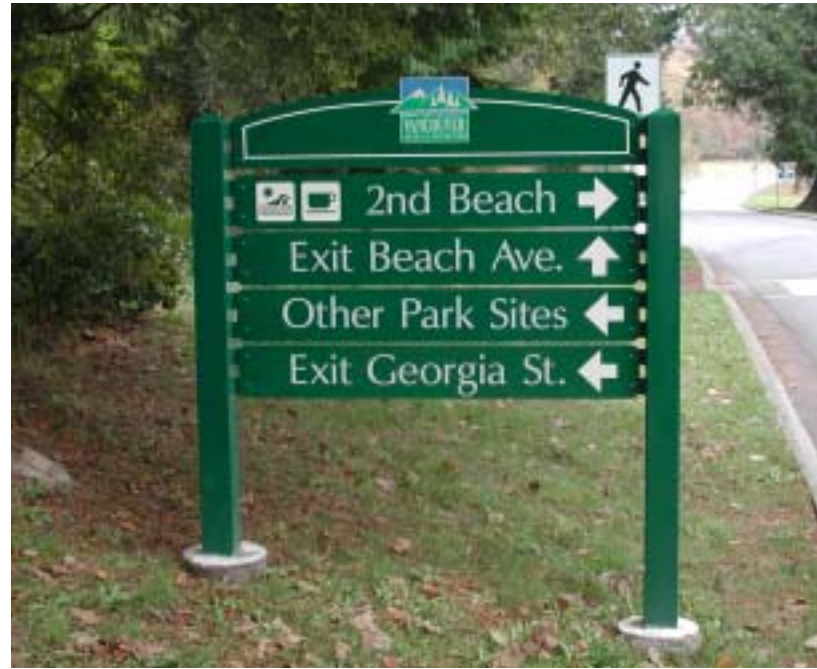
- 9. Signage obscured by foliage.
- 10. Miniature Train Parking Exit.  
Add directional sign to additional parking and other park attractions.
- 11. Add washroom pictograms to signs as appropriate.
