Conservation Plan for Stanley Park's Hollow Tree

Prepared at the Request of Vancouver Park Board
by the Stanley Park Hollow Tree Conservation Society

October 14, 2008

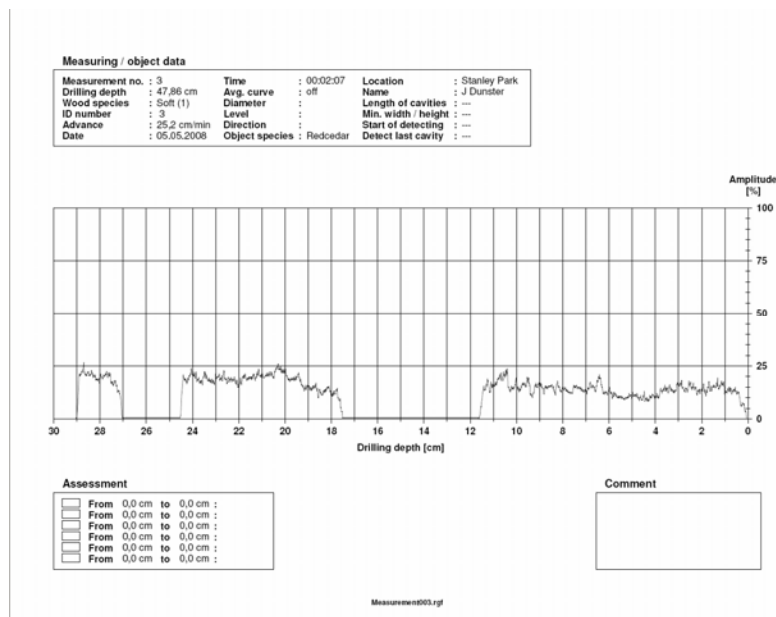
A second stage of study took place during the period of Park Board deliberation. Consulting arborist and professional forester Julian Dunster, a member of the Conservation Society, carried out a preliminary inspection of the Hollow Tree, including testing the wood making up the base region of the tree up to a height of 6 ft. (See the illustration below depicting one of the preliminary Resistograph measurements he took.) Dr. Dunster concluded, based on his many years of experience, that the higher reaches also have sufficient quantities of sound wood to ensure that the major pieces comprising the tree are not in any danger of disintegration. However, it will be necessary to discretely and firmly connect the major pieces to one another to maintain the integrity of the Hollow Tree as a whole.

An example of Resistograph measurements taken on the Hollow Tree

The resistograph testing mentioned above established the important conclusion that the wood making up the solid portions of the Hollow Tree is primarily sound. We also wished to carry out a laboratory test of the strength of the wood, but according to best conservation practise we did not remove any of the wood of the Hollow Tree. Instead, we obtained a sample of the inner wood of an ancient red cedar stump found on private property. Just as with the Hollow Tree, the exterior surface appears very weathered, but where there was firm wood, it was very sound. We cut a clear piece of that ancient wood, measuring 1” by 1” by 16” and its strength was measured by Professor Frank Lam in the UBC Faculty of Forestry. Professor Lam was pleasantly surprised to find that this wood was as strong, if not stronger, than Western Red Cedar harvested from living trees today. This is not particularly surprising, as the wood that makes up the trunk of any tree, living or dead, is not truly alive, just as is the case for human finger nail material or hair. Until wood rots, it lasts indefinitely. In the case of Western Red Cedar, rot may only penetrate inward very slowly and where the rot has not reached, the wood can remain very solid. To put it

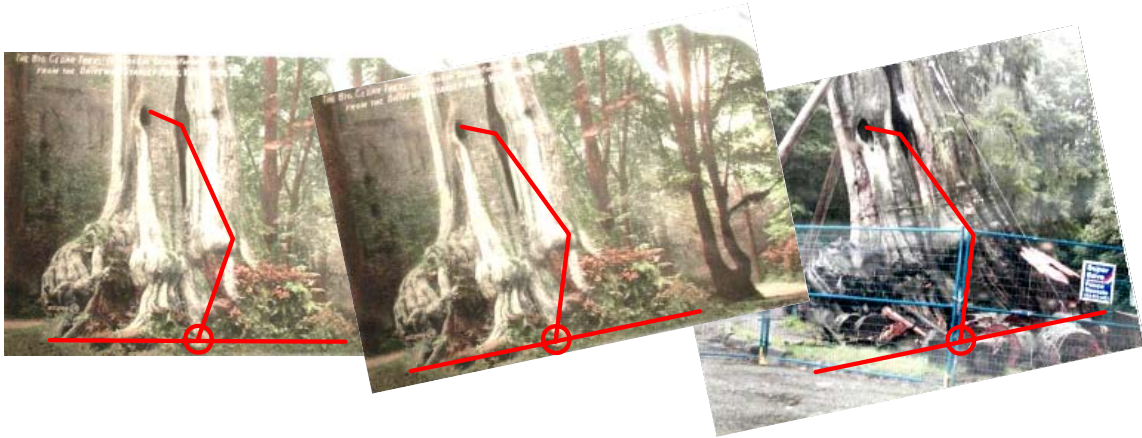
The three views below were taken from the north. Again it is clear that the tree has tilted as one unit, and importantly it is possible to see that it has tilted, effectively, about approximately a north-south axis passing through the center of the tree.

Historic and recent side views showing the tree was originally vertical and has rotated 11 degrees about a central north-south axis.

The root structure of the Hollow Tree has been studied by means of careful non-damaging excavation. It was found that the peripheral roots that spread visibly outward are providing no support and probably have not done so for a very long time because long ago they rotted away underground. (A much faster process due to presence of moisture and soil microbes.) In contrast, further inside, and close to a central pivot line, there are several large vertical roots extending deeply into firm soil. These support the weight of the Hollow Tree, but because they are close to the center line, they do not provide quite enough torsional stability to prevent very slow tipping over many years. This observed situation with the roots is consistent with the photographic record of the tipping.

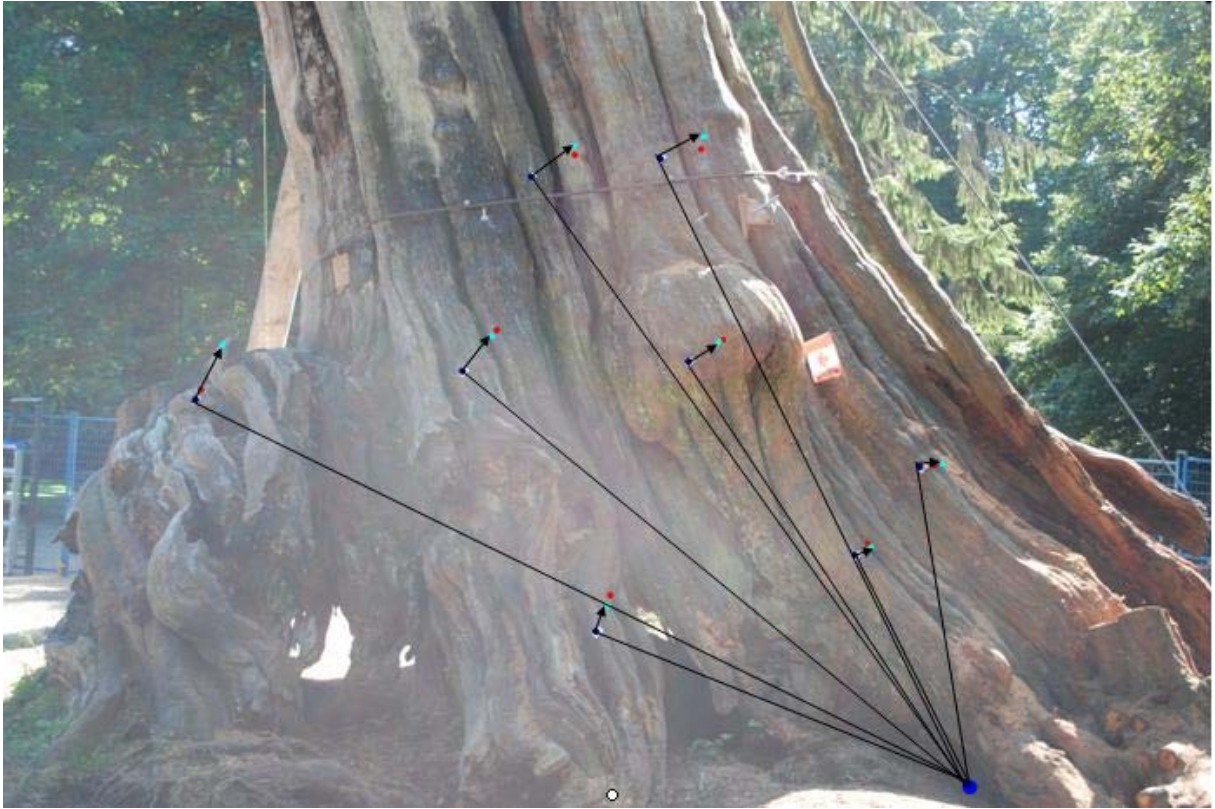
To test the feasibility of this idea of righting the tree, we carried out a small deflection test in which we employed a carefully controlled hydraulic jack to raise one of the support timbers 3 inches. At all times we measured the force required to achieve the displacement and we gathered force vs. displacement data. This data displayed a characteristic called hysteresis that provides evidence that the ground was yielding to the small displacements we introduced. We also employed quantitative imaging methods to observe the resultant deflection patterns in the Hollow Tree. These showed that the Hollow Tree deflected as one solid unit, rotating that small amount back around its original pivot line. Although these observations do not guarantee that the tree can be pivoted all the way back, they do make this seem very likely. The photo below depicts some of the mathematical analysis of the observed deflection, with movements exaggerated by a factor of 10.

10X deflection representations. Red dots show observed displacement and the black arrows and cyan dots depict the best fit rotation.

The jacks will then be used to bring the Hollow Tree back to its original vertical orientation. It may be necessary to proceed quite slowly to avoid causing undue deformation to the Hollow Tree. The previous deflection response test suggests that this is feasible. In the worst case, this may require loosening of the soil on one side of some of the major roots.
