EXTREME WEATHER IMPACTS & DAMAGES

Safety, assessment and
recovery plan

Regular Board Meeting
Monday, January 24, 2022

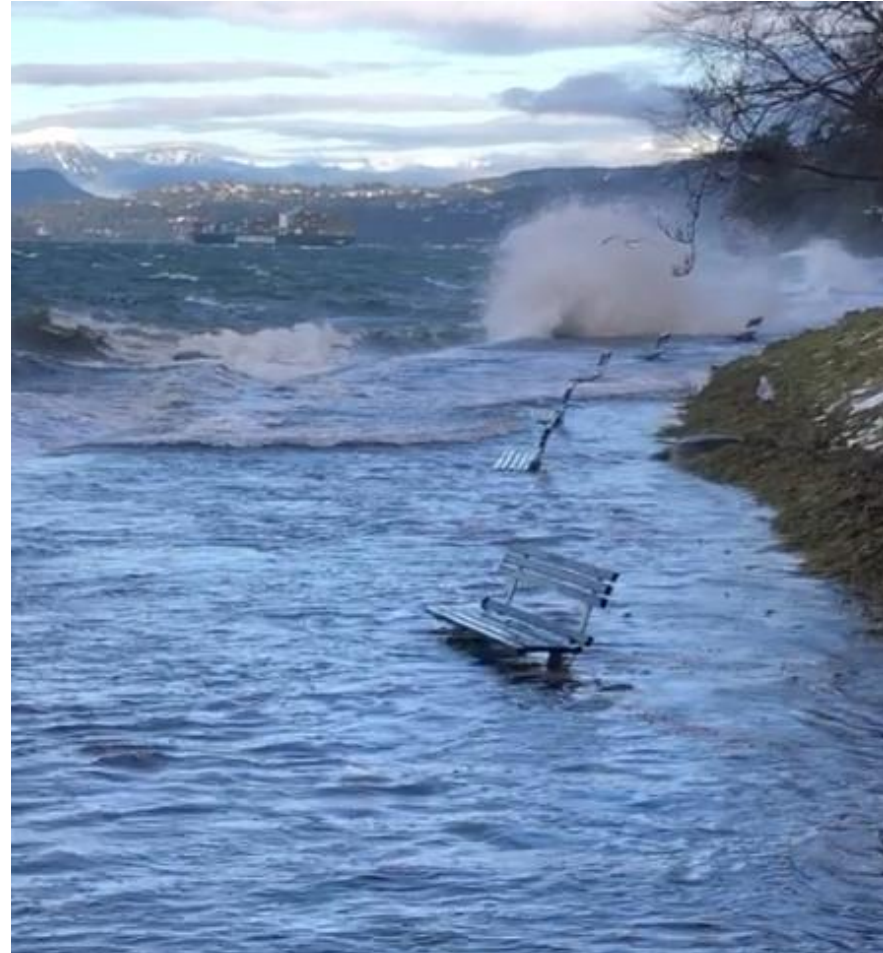
Storm Surge – Regional Context

- Measured peak water level at Ambleside was 5.63 m at 10:00 am, resulting in 0.8m storm surge at highest tide
- However, water levels remained consistently high throughout the morning with storm surge peaking at 1 m at 11:30 am
- The cyclical nature of the storm also increased the battering effect on the shoreline
- Storm impacted Vancouver & West Vancouver shorelines most severely in the lower mainland

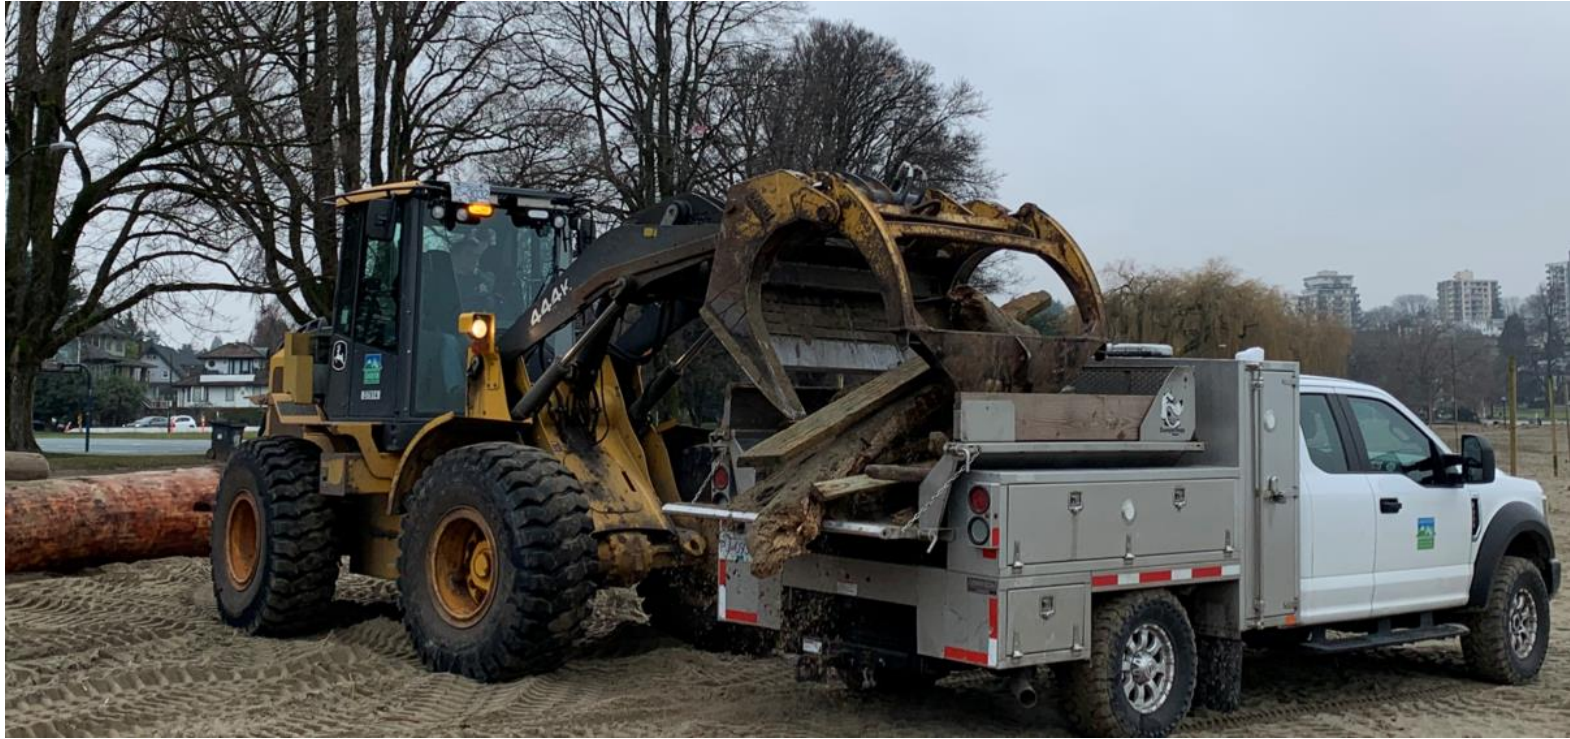
Removing Debris

- Closure of damaged sections
- Removing debris e.g. capstones, logs and secure sites
- Minimizing further damage and focusing on public safety
- More king tide events in the coming weeks – still vulnerable
- Stabilization of seawall for next King tide event Jan 31st, Feb 1st + 2nd
- Continue to be proactive in anticipating & preparing for future extreme weather events and enhance emergency planning
- Closing the seawall and other marine and other park amenities to the public will become more frequent (need to build in culture)

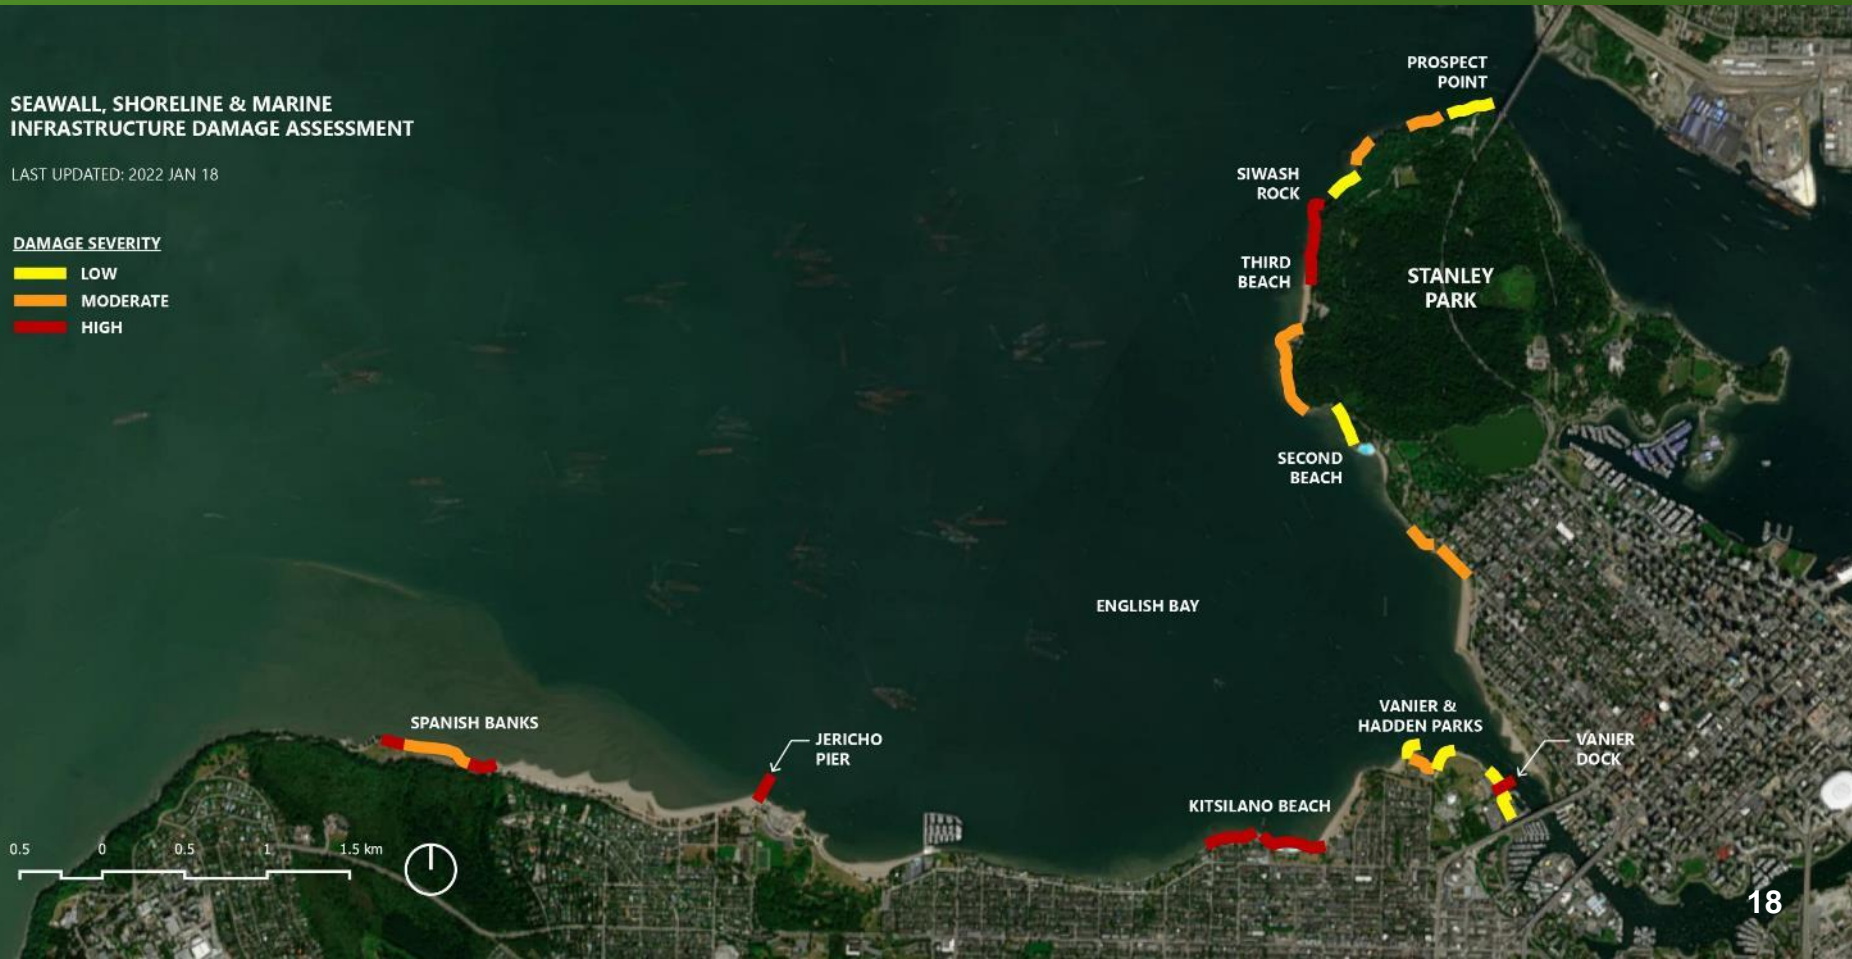
SEAWALL, SHORELINE & MARINE INFRASTRUCTURE DAMAGE ASSESSMENT

DAMAGE SEVERITY

- LOW
- MODERATE
- HIGH

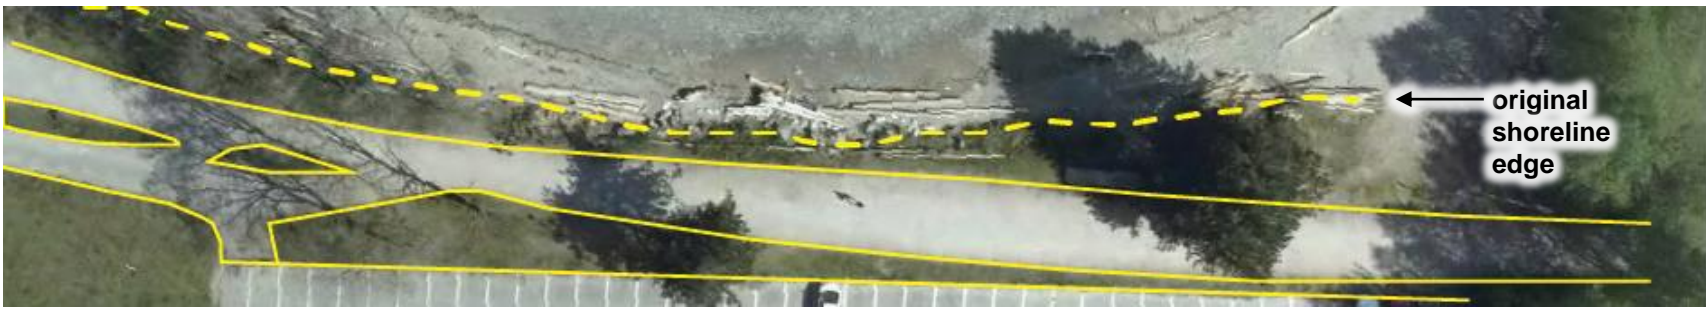
June 2019

original shoreline edge

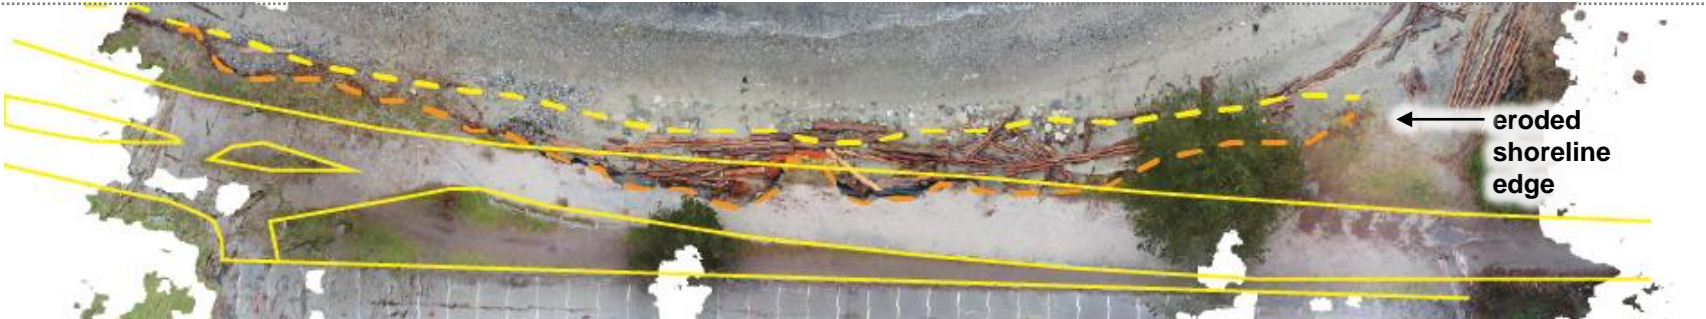
Dec. 6, 2021

eroded shoreline edge

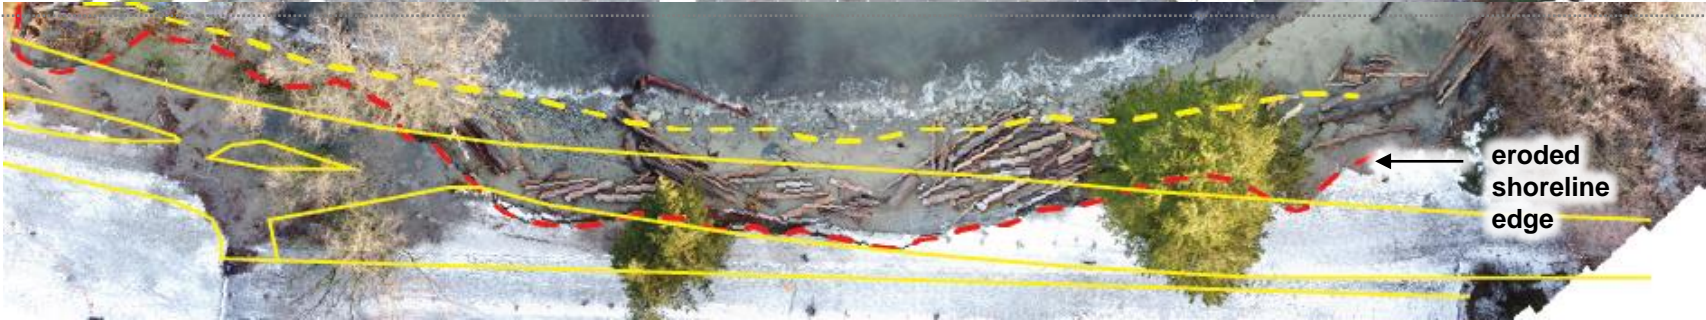
Jan. 9, 2022

eroded shoreline edge

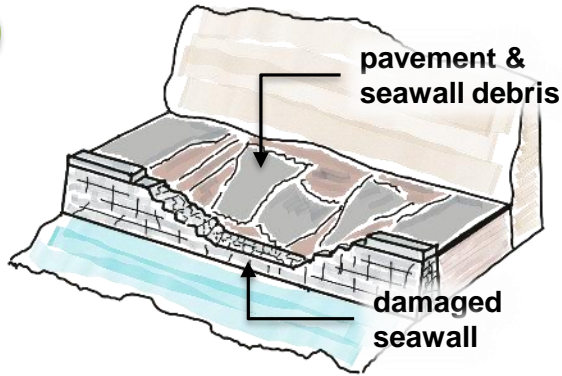
1

✓ Remove Debris & Assess

- remove debris and unstable sections of pathway and seawall
- assess the condition of the seawall and pathway structure and determine short-term and permanent repair methodology

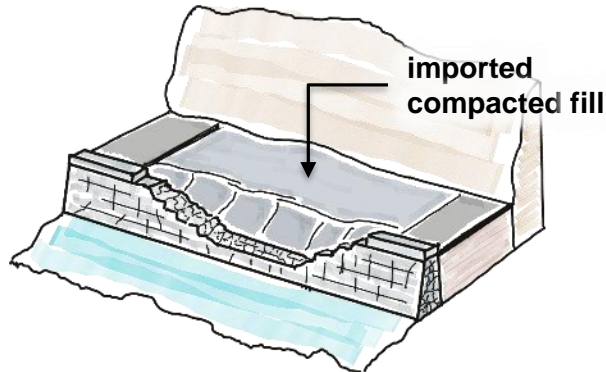
2

✓ Construct Temporary Path

- import gravel to fill collapsed and eroded section of the seawall
- compact the imported fill to allow construction equipment and personnel to access other areas to start the repairs
- these sections are not safe for public use

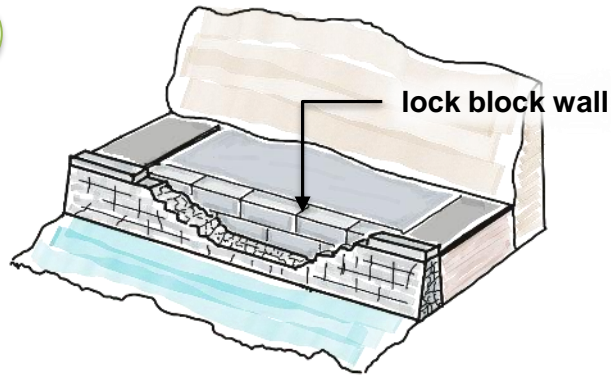
3

□ Build Temporary Retaining Wall

- build a temporary lock-block retaining wall to prevent further damage and erosion of seawall during next king tides
- continue coping stone repairs in other areas

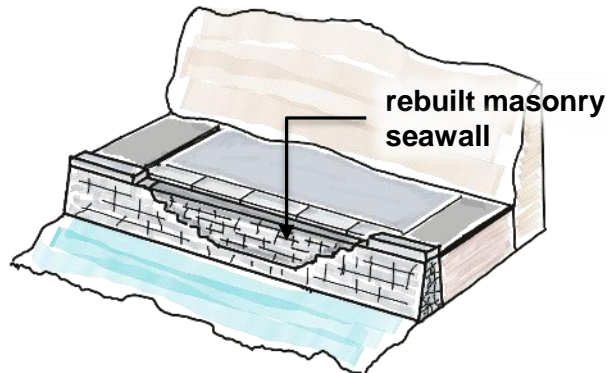
4

□ Rebuild Seawall & Pathway

- assess the seawall and temporary structures and adjust permanent wall detail
- rebuild the exterior masonry seawall
- rebuild the seawall path structure and repave

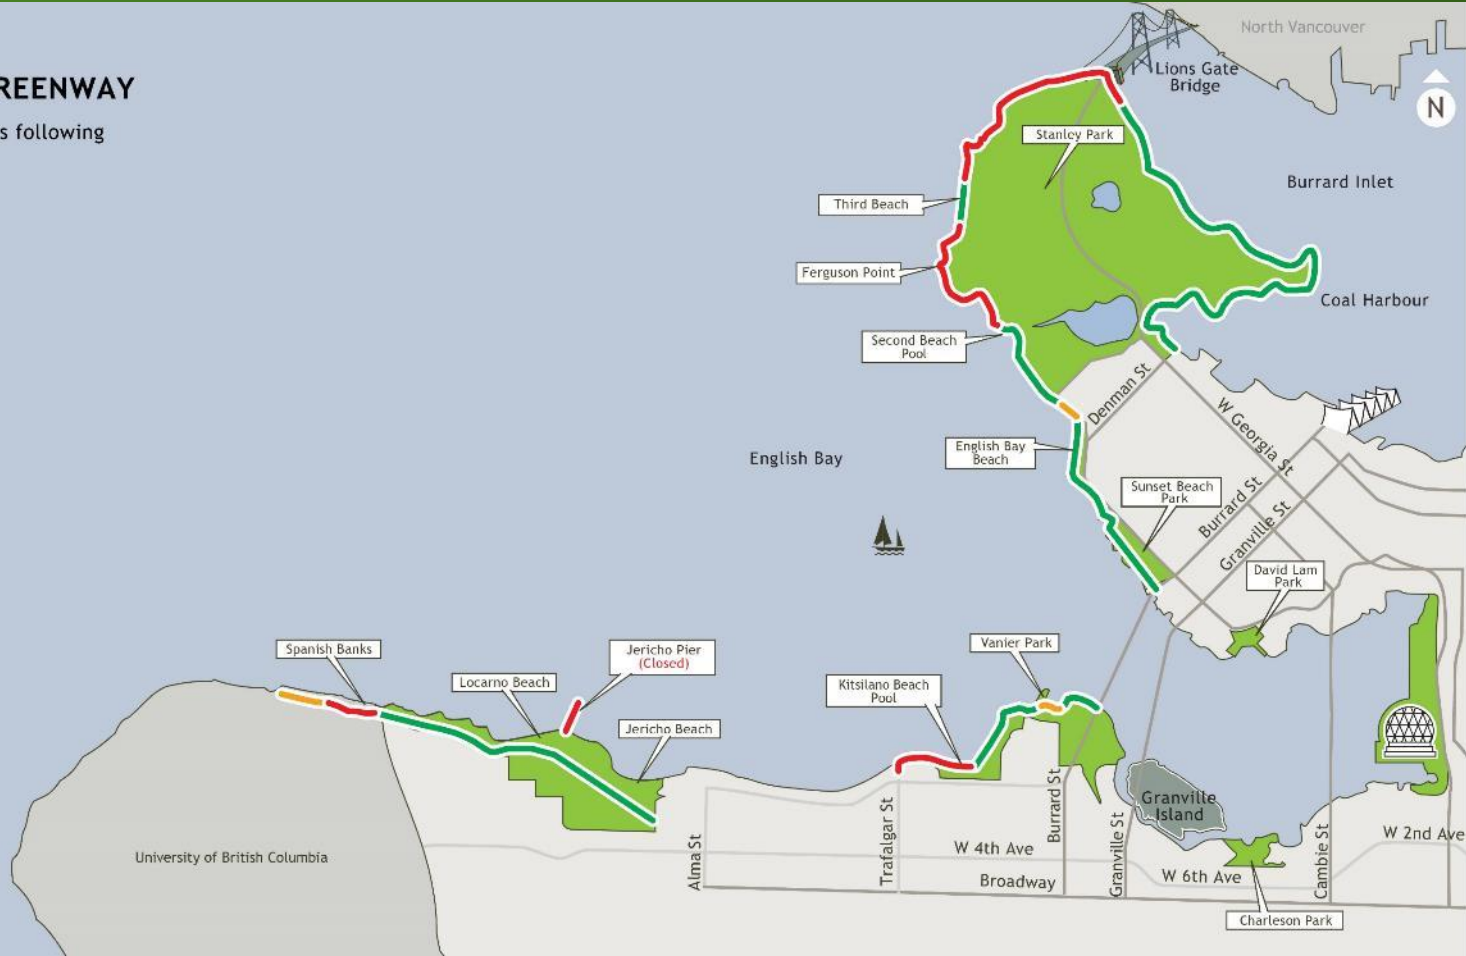
Current Status of Seawall & Pathways

Status of seawall and seaside pathways following January 7, 2022 storm
