KITSILANO OUTDOOR POOL

Current State Update

Regular Park Board Meeting
Monday, April 8, 2024

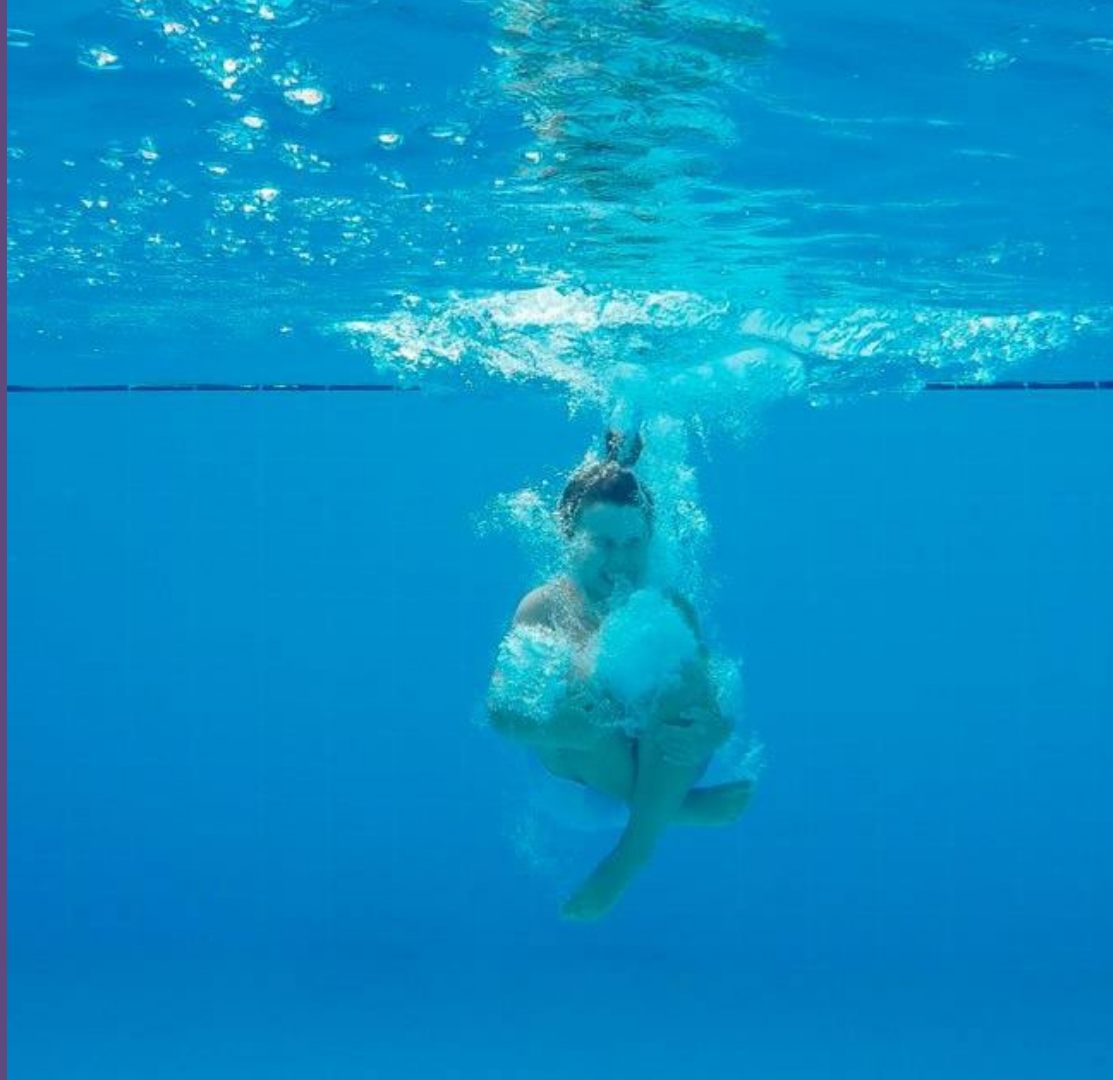
- REFM leading extensive investigations to identify sources of water loss (30,000 L/hour);
- Highlights include:
 - Concrete removal and pipe scoping
 - Challenges with camera scoping

- Investigation identified water loss occurring at multiple locations, i.e.:
 - expansion joint;
 - pipe joint (deep end);
 - supply head (consolidated debris); and
 - supply head (collapsed pipe)

- Repairs underway

- Pool drain repairs
- Expansion joint and pipe joint repairs
- Clean outs in pool basin installed and scoped

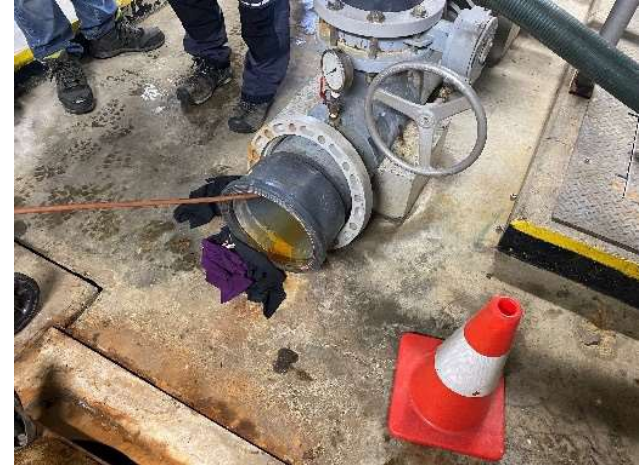
Main water supply & 200 ft video scope

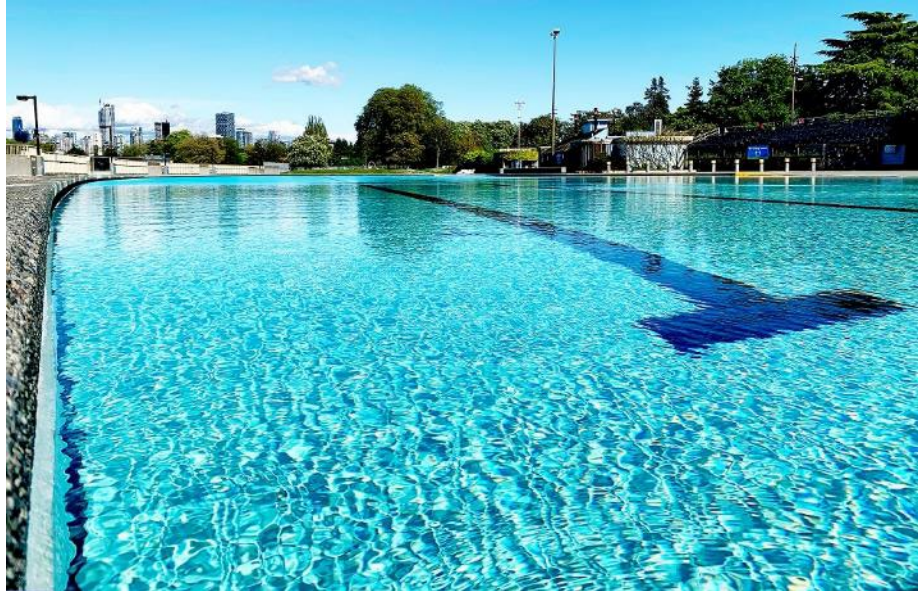
- Approximately \$5M spent over past 8 years for capital works (planned as well as unplanned)
- Maintenance costs increasing year over year
- Storm and King Tide damage highlighted vulnerabilities
