TO: Park Board Chair and Commissioners
FROM: General Manager – Vancouver Board of Parks and Recreation
SUBJECT: Jericho Beach Park Pier - Next Steps

RECOMMENDATION

THAT the Vancouver Park Board direct staff to deconstruct Jericho Beach Park Pier while keeping in place and suitably reinforcing the breakwater so as to maintain protection of the Jericho Sailing Centre harbour.

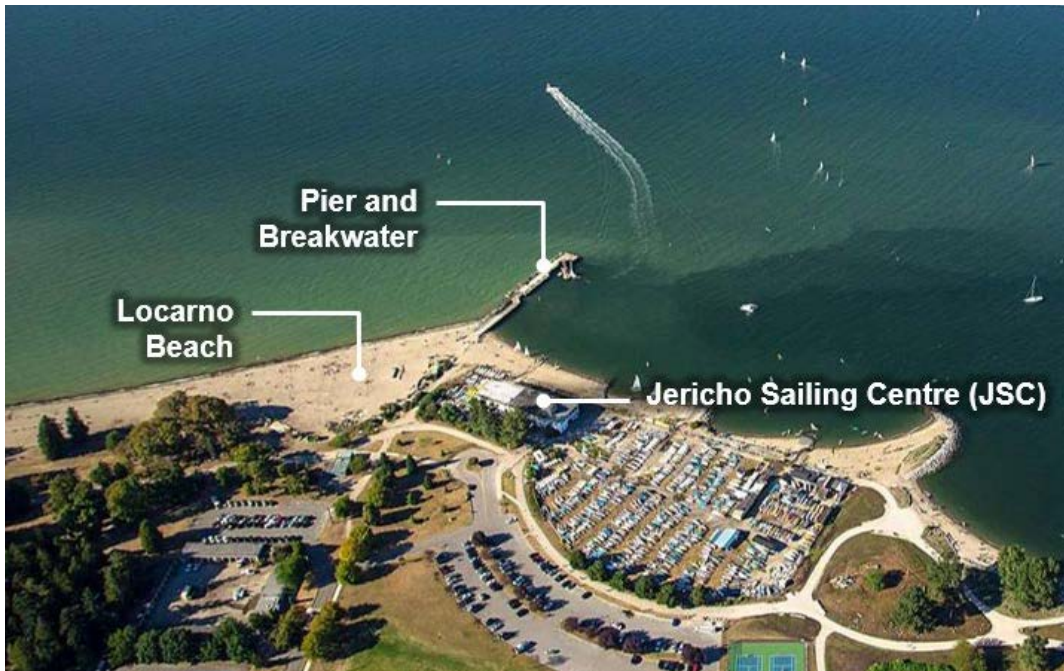
Fig. A: Photo of Jericho Pier and Jericho Sailing Centre

The pier is located within Jericho Beach Park on lands that are archaeologically, culturally, and ecologically significant to the Host Nations. The pier is timber platform structure built on 80 year old piles. Originally a component of the Canadian Air Force base located at this site circa 1942, the pier underwent refurbishment in 1977 and has been maintained and operated by the

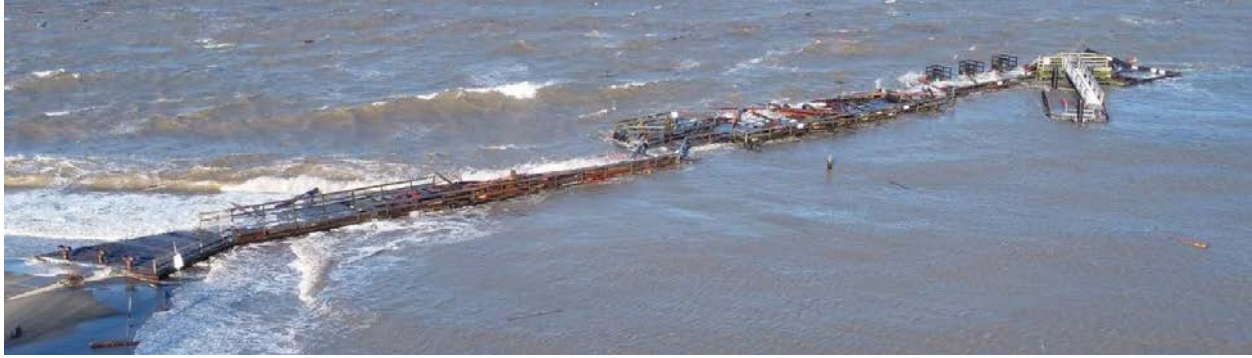
Fig. B: Deck inundation during Jan 2022 storm

In November 2021, the pier suffered moderate storm damage which prompted the closure of the pier. In January 2022, a combined storm surge and king tide event caused significant additional damage as the deck was flooded and impacted by log debris as shown in the images below. The pier remains closed to the present day.

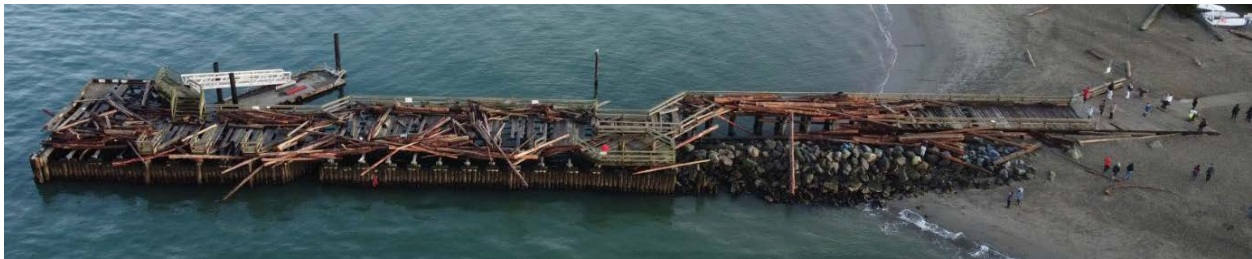
Fig. C: Log debris accumulated following January 2022 storm. Breakwater visible on near side of pier

When the pier was operational, residents and visitors would visit to enjoy the views of Vancouver's Burrard inlet. The end of the pier was a fishing and crabbing spot, and the connected concrete float was used by marine rescue vessels. The pier has a timber breakwater and rock mound embankment, visible in Fig C below, which shelter Jericho Sailing Centre (JSC) harbour from oncoming waves.

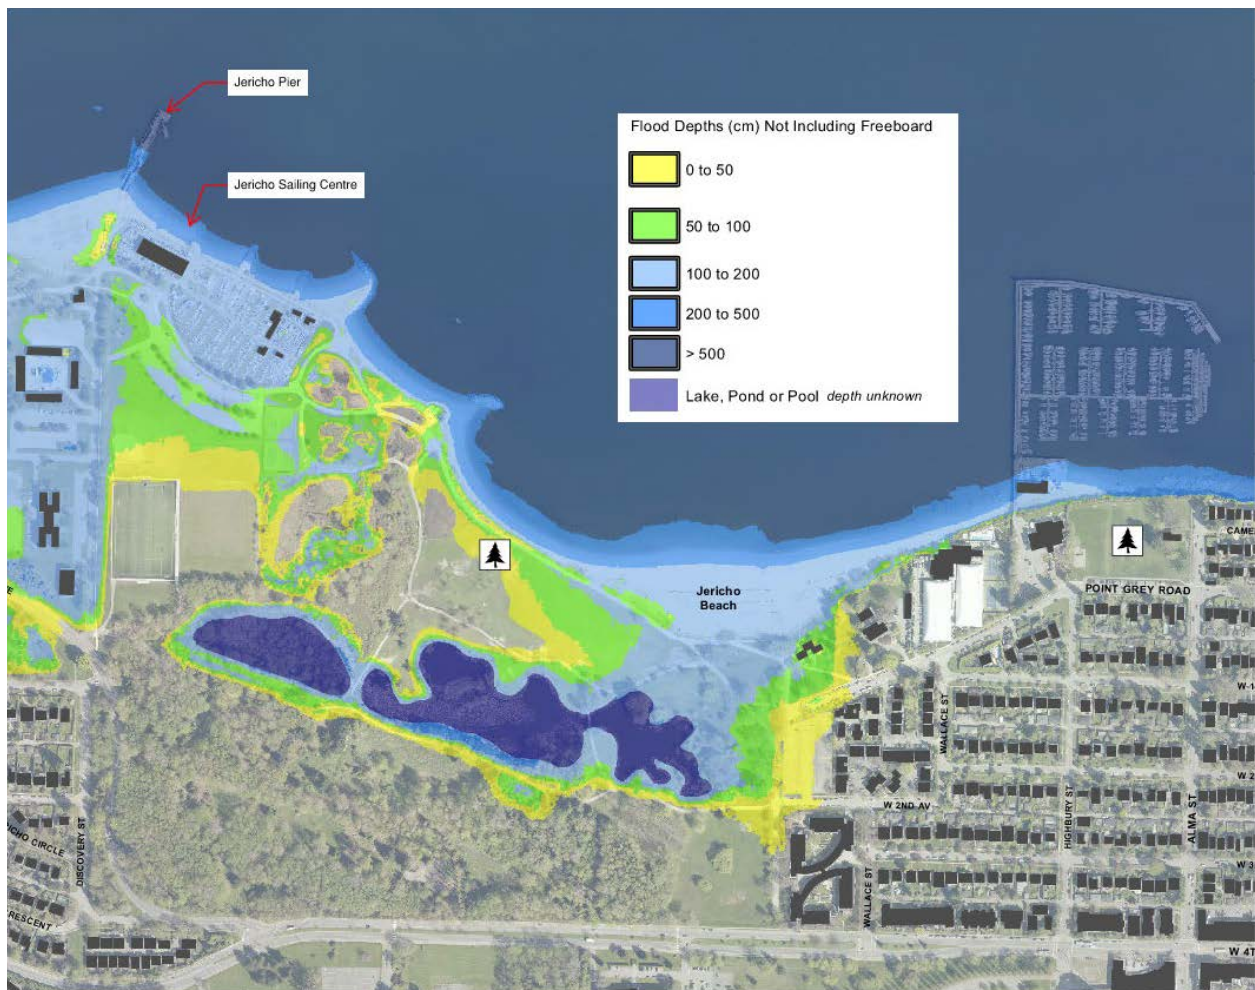
Future Coastal Flood Plain: Year 2100, 1m Sea-Level-Rise, 1/500 Flood Event

The map below delineates the potential for coastal flooding in the year 2100 assuming a 1.0m sea level rise and a 500-year return period ocean event. A 500-year return period ocean event means that, on average, there is a one-in-500 chance that the flood level mapped could be equaled or exceeded in any one year (or that there is about a one-in-10 chance that the flood level mapped could be equaled or exceeded in a period of 50 years).

The figure shows much of Jericho Beach Park being flooded with 100 to 200 cm of water.

Over the years, the pier has been repaired several times in response to storm damage. During recurring storm surge events, the pier deck has been fully inundated. Climate change is increasing the frequency of severe storm events, and sea level rise is expected to significantly impact this site, as shown in Appendix A.

2. **Climate Change:** Increasingly frequent and severe coastal storms will continue to impact this site. The pier is located within the coastal floodplain and sea level rise will exacerbate the magnitude, frequency, and extent of coastal flooding at Jericho Beach Park. The future coastal floodplain at Jericho Beach Park is shown in Appendix A.
